<u>Health and Safety file. Roman Baths Development</u> <u>Project</u>

Observations and catalogue relating to Conservation work undertaken, fixings used, information for future residual risks and safe systems of work for future moves.

MINERVA STONE CONSERVATION

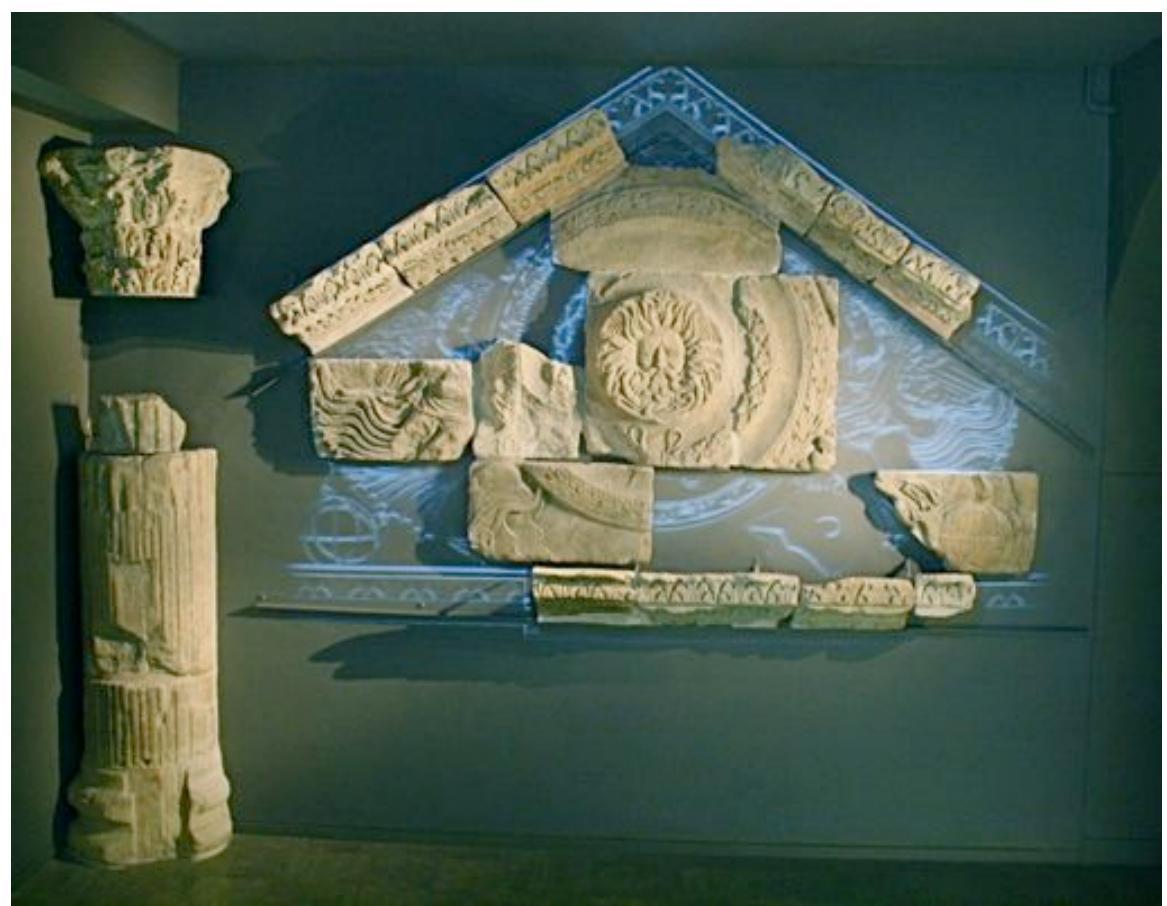
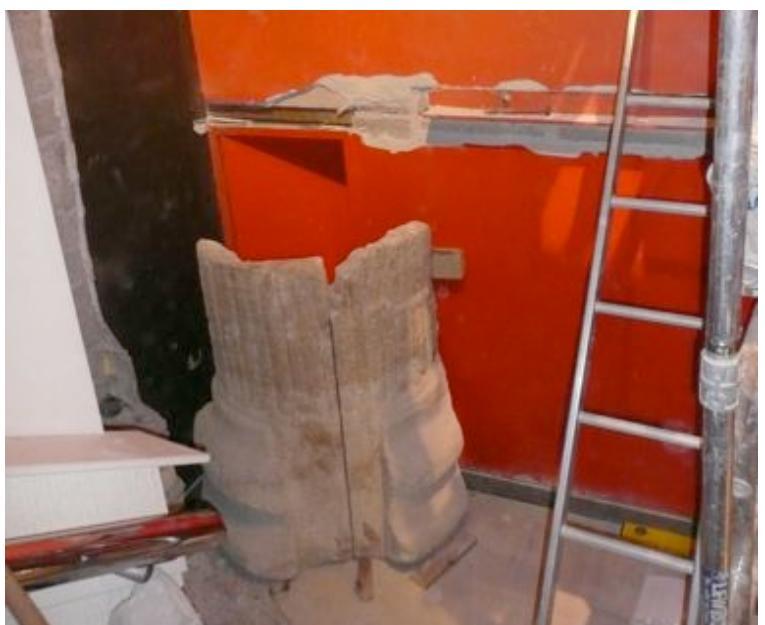
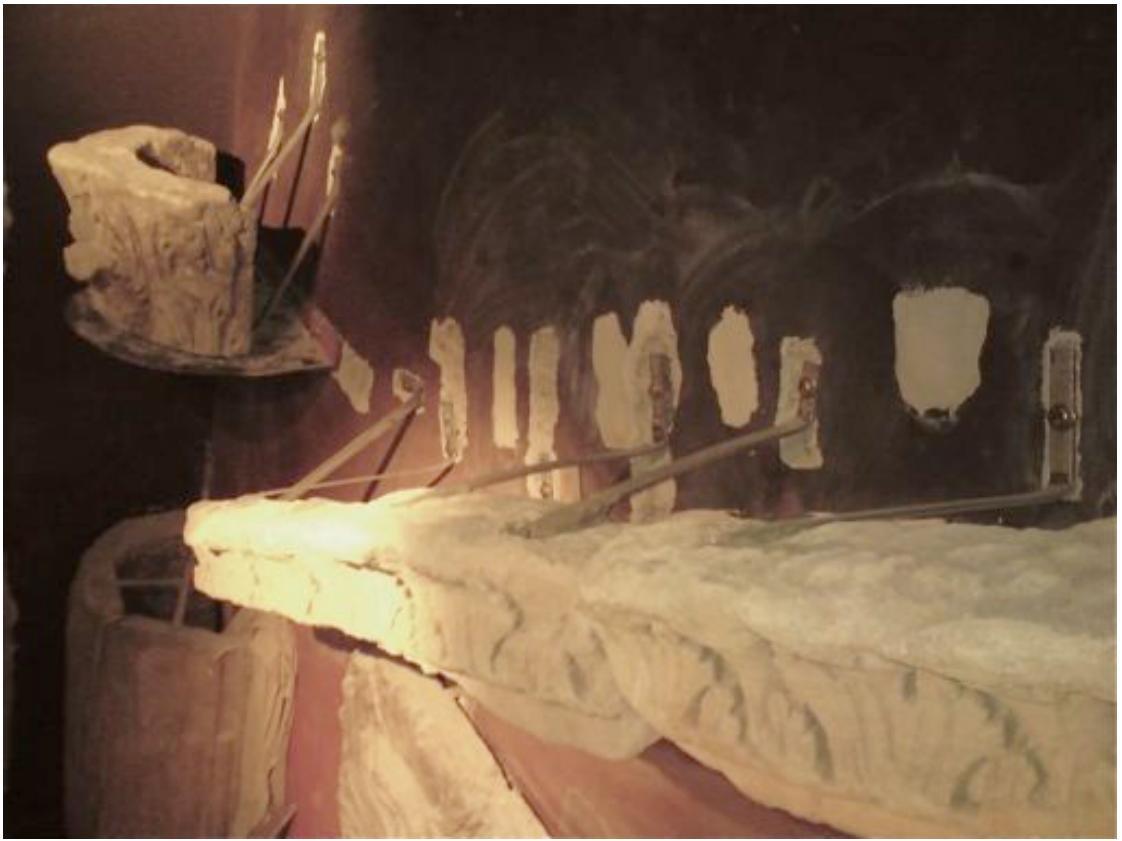
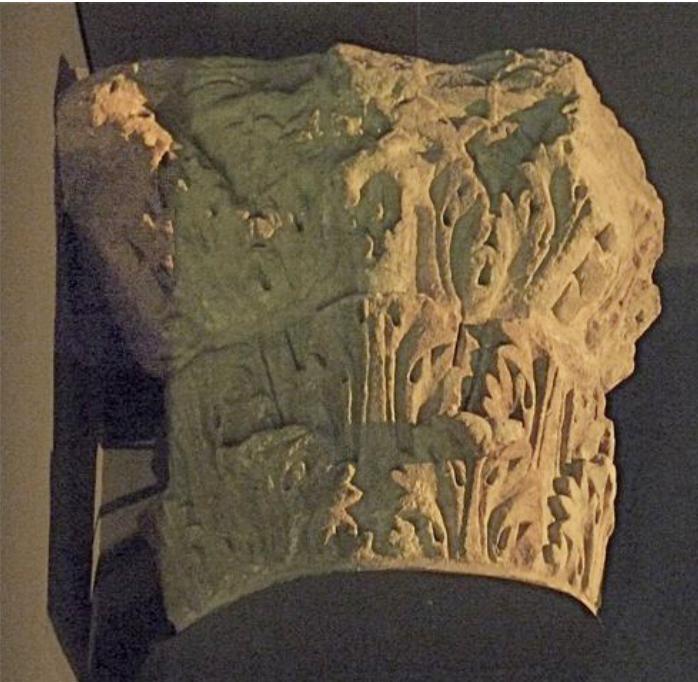
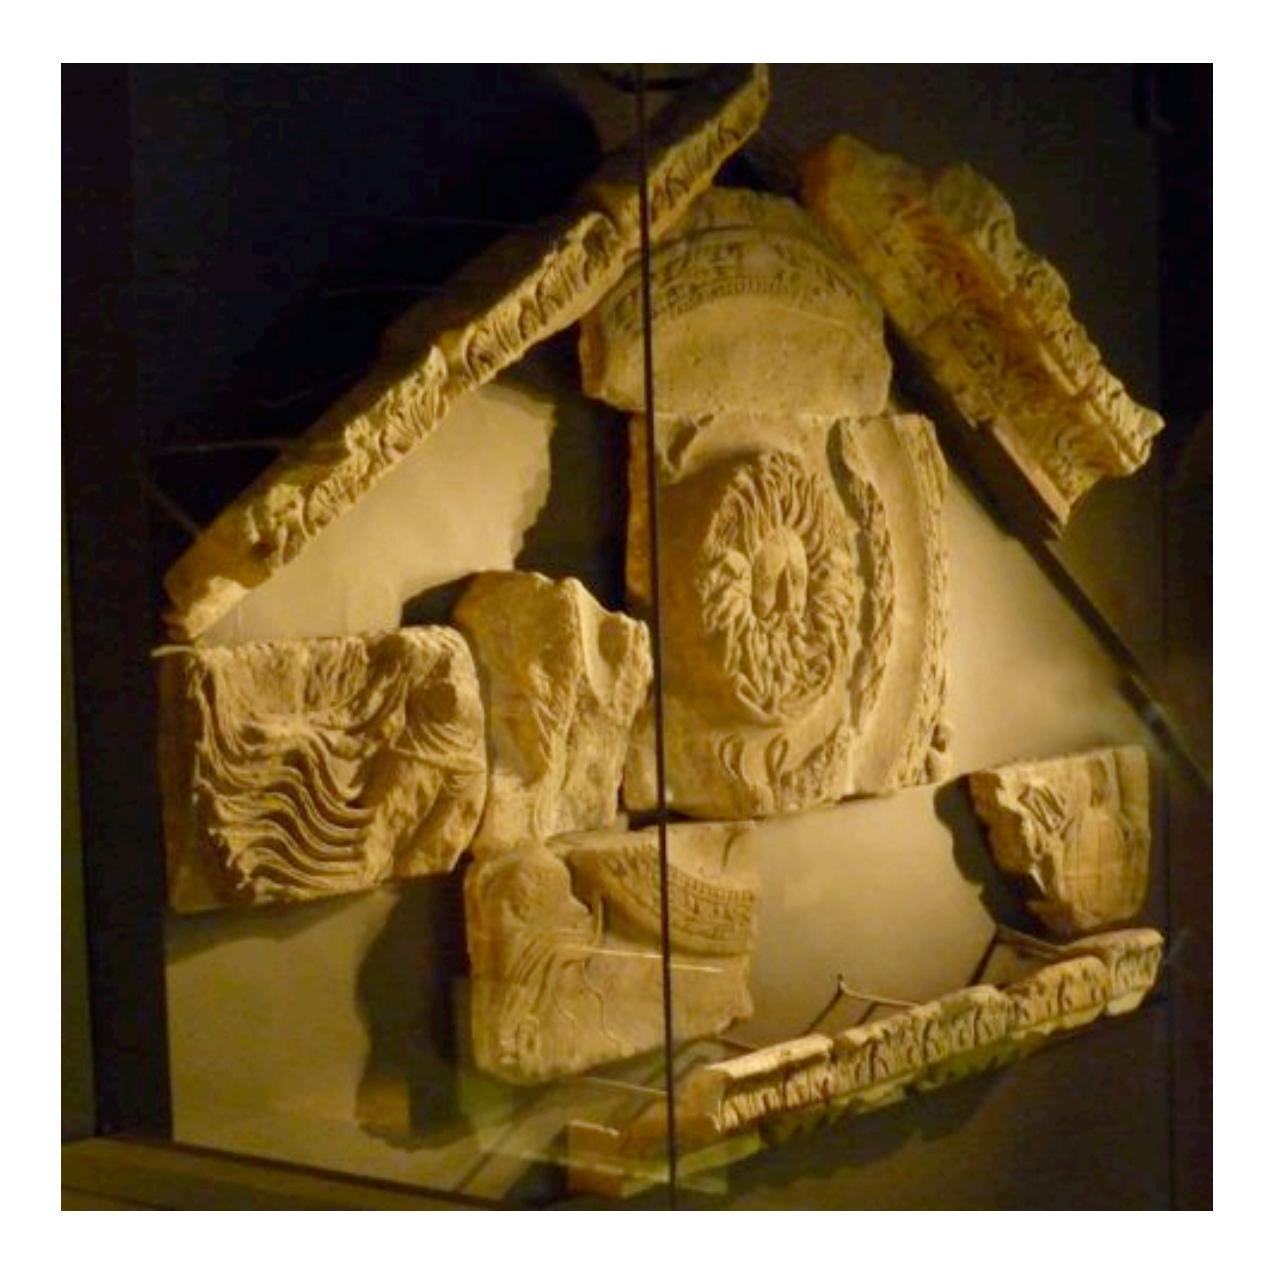
Re-arrangement of Temple Pediment.

Elements of the "Gorgon Pediment" were adjusted and moved, the angle of the cornice was adjusted. The adjacent Column and Capital was moved and fixed into new wall positions.

Vacuum cleaned and gently cleaned.

Stainless steel flat bar, felt cushion (fixed around the body of the stone) seated on equal angle- iron bracket.

View down Cornice showing fixing method (into pre existing holes cut into the stones)

Newly displayed Capital sitting on wall fixed steel plate and restrained by stainless Steel bar fixed into original fixing slots (the capital received colour matched mortar repairs).

Check fixing points and vaccum annually.

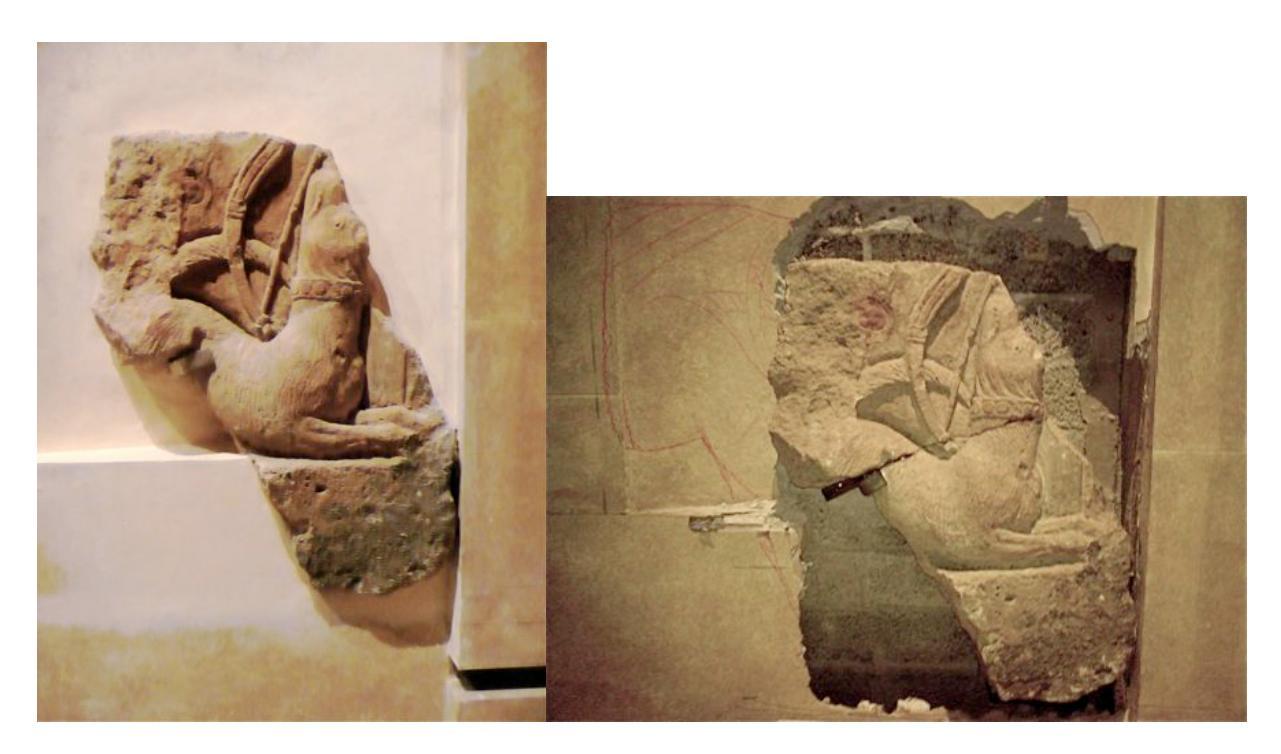
1983.1.384 Stone relief of hound and Diana

Sculpture moved from shelf/storage and fixed into 4seasons façade, the façade was excavated to a depth of 4 inches to ensure a flush frontal plane, Object gently cleaned and old unsightly cement repair removed and conserved.

Bedded onto Lime putty mortar and secured/held with Stainless Steel Bracket fixed into block wall. Gypsum plaster finish.

Cutting into blockwork has reduced the distance to the Asbestos-containing cavity to approx 100mm from 200mm.

Inspect surrounding plaster for cracks.

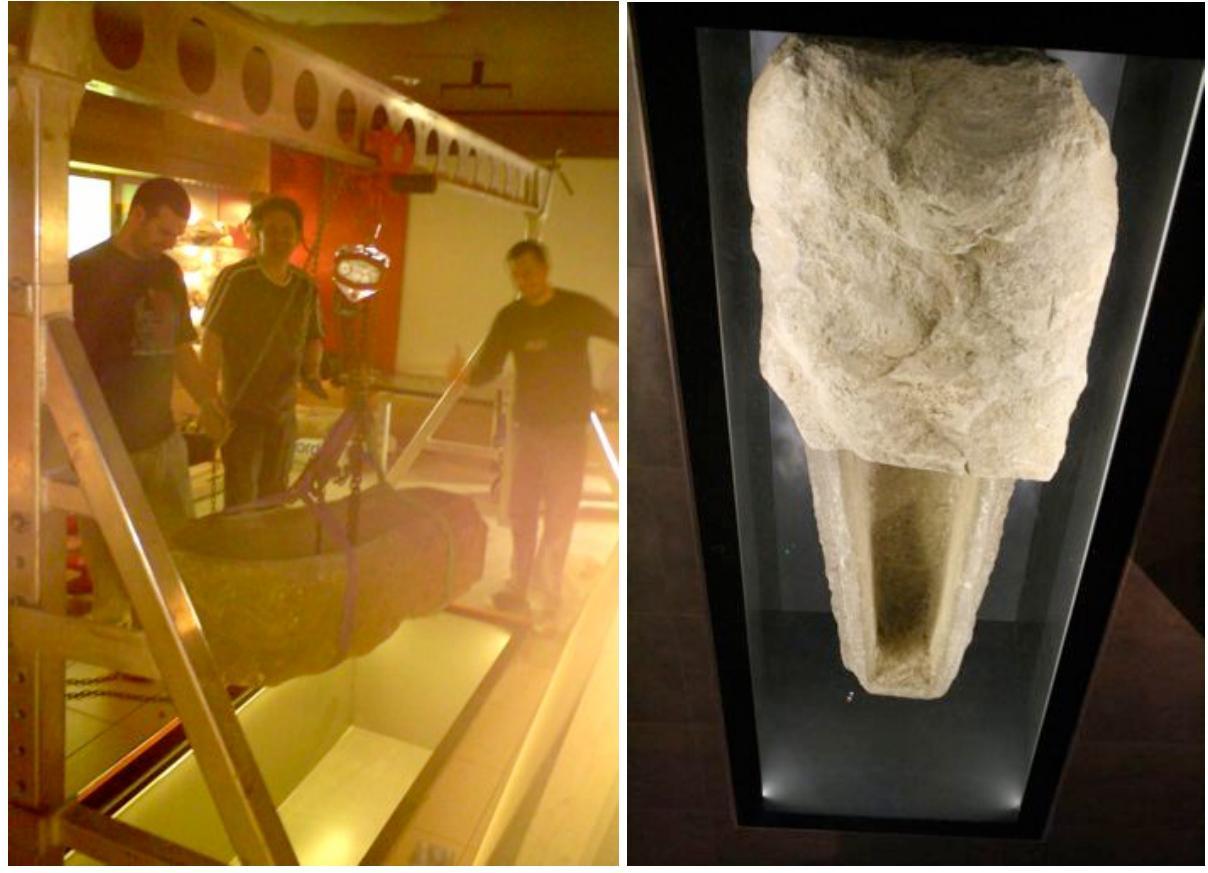
1981.9a-b Large coffin and lid

Coffin moved from display/storage and fixed into new position in floor mortice. Object cleaned.

Coffin rests on wooden wedges.

None apart from yearly vacuum.

Use gantry system for safe lifting.

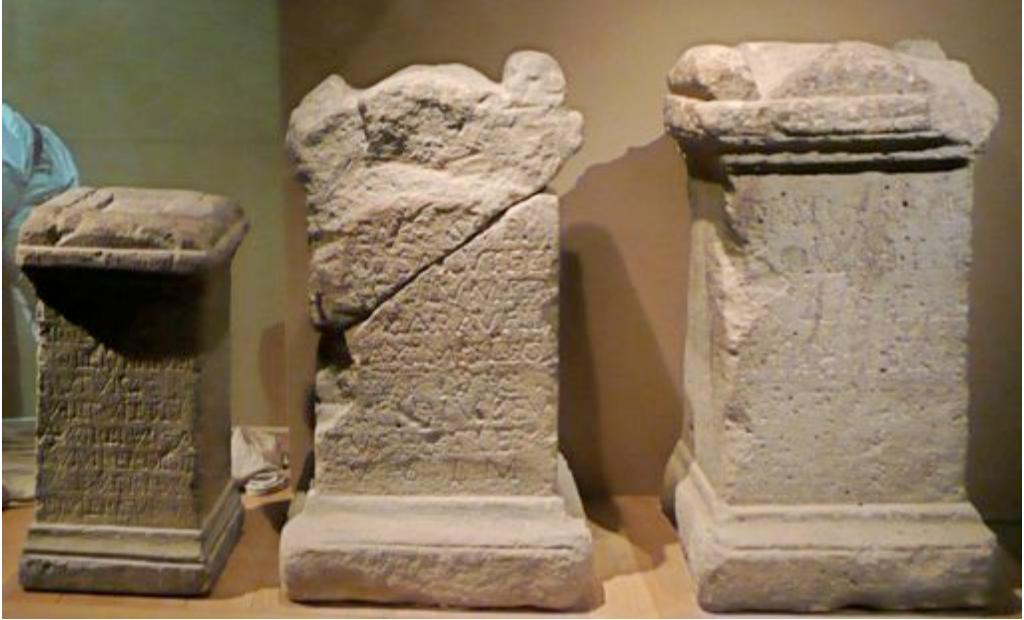
Plinth Based Altars.

Altar moved from display/storage and fixed into new position on floor plinth. Object cleaned.

Stainless steel pegs fix the 2 sections together.

None apart from yearly vacuum.

Use gantry system for safe lifting.

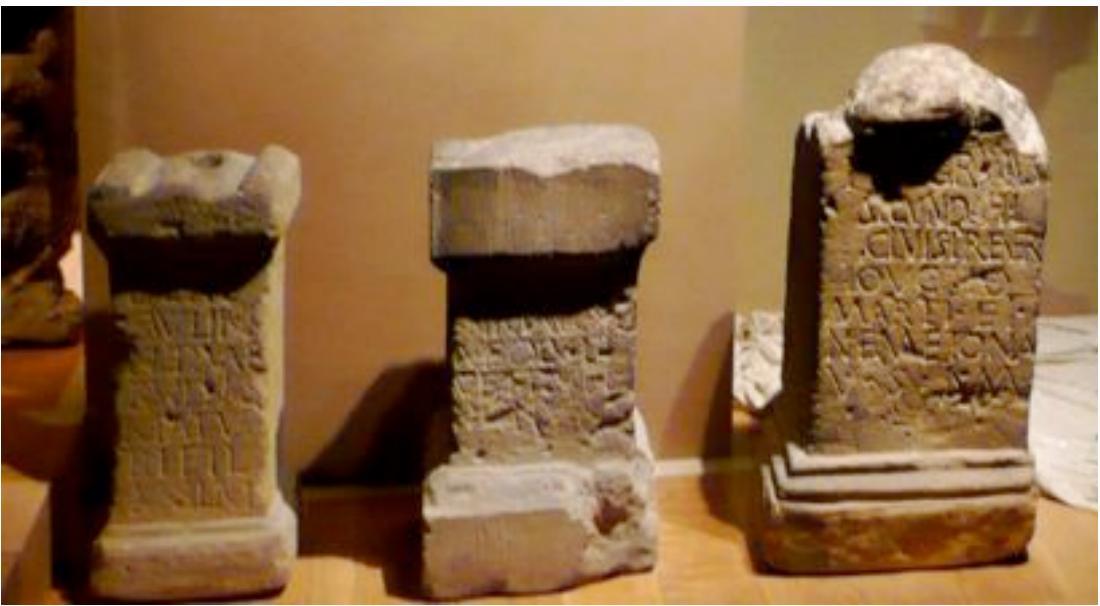
Plinth Based Altars

Altar moved from display/storage and fixed into new position on floor plinth. Object cleaned.

None

None apart from yearly vacuum.

Use gantry system for safe lifting.

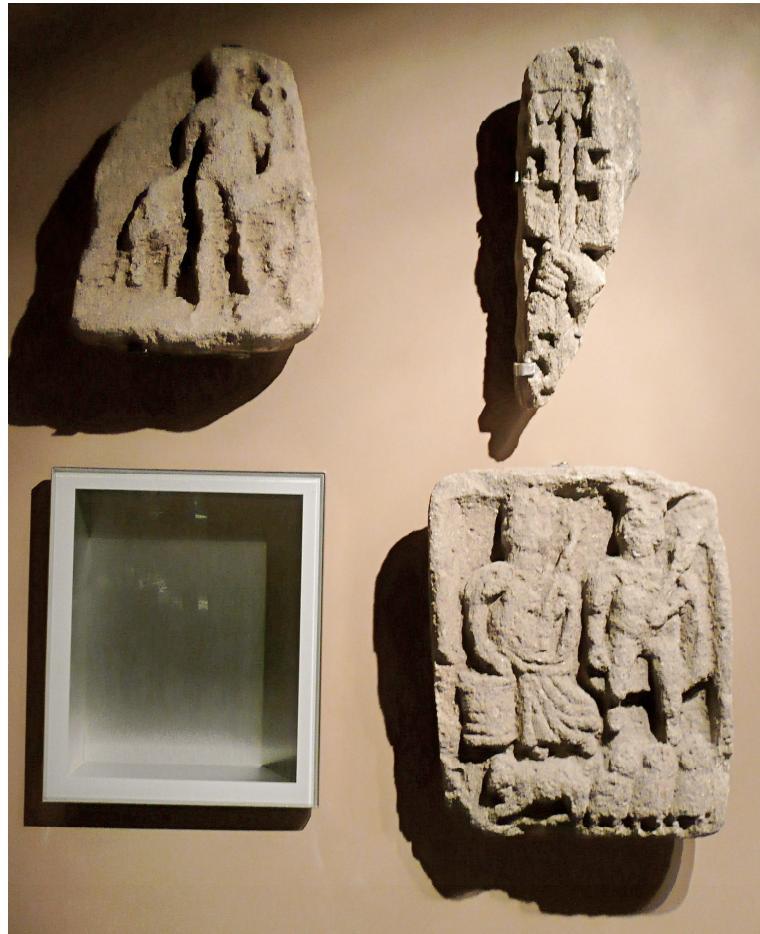
Wall fixed Relief's

Description 1. of work undertaken. Relief moved from display and fixed into new wall position. Object Vacuum cleaned. 2. Fixings used. Stainless steel flat bar, felt cushioning. 3.Future maintenance/conserv ation requirements. None apart from yearly vacuum. Potential future 4. risks and considerations. None.

Relief moved from display and fixed into new wall position. Object Vacuum cleaned.

Stainless steel flat bar, felt cushioning and stainless steel pegs (fixed into preexisting holes fixes the object to its seat.

None apart from yearly vaccum.

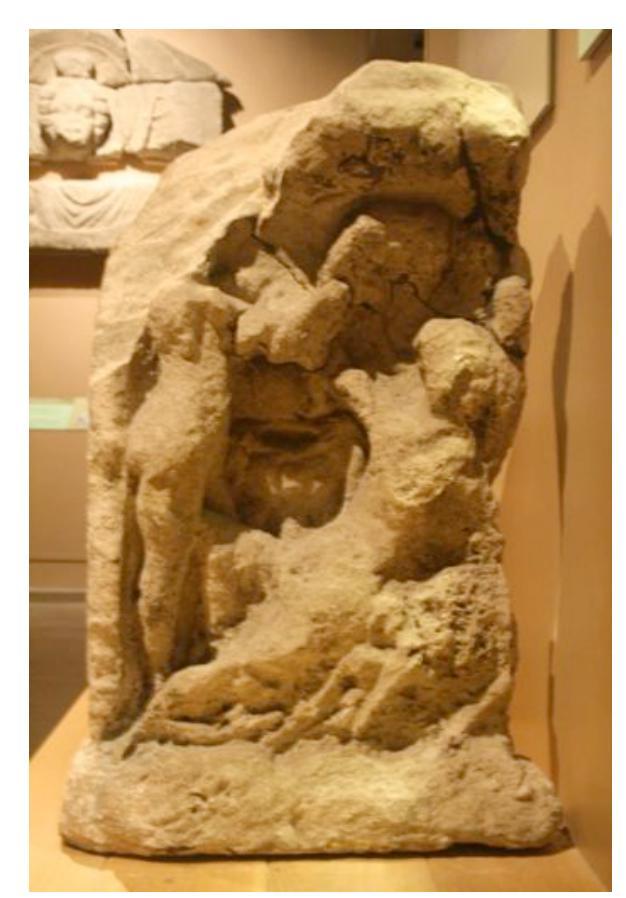
1986.4.5 Aesculapius Block

Description work 1. of undertaken. Relief moved from display and sat on into new position on plinth. Object Vacuum cleaned. 2. Fixings used. None 3. Future maintenance/conservation requirements. None apart from annual vaccum. 4. Potential future risks and considerations. Test for stability every year.

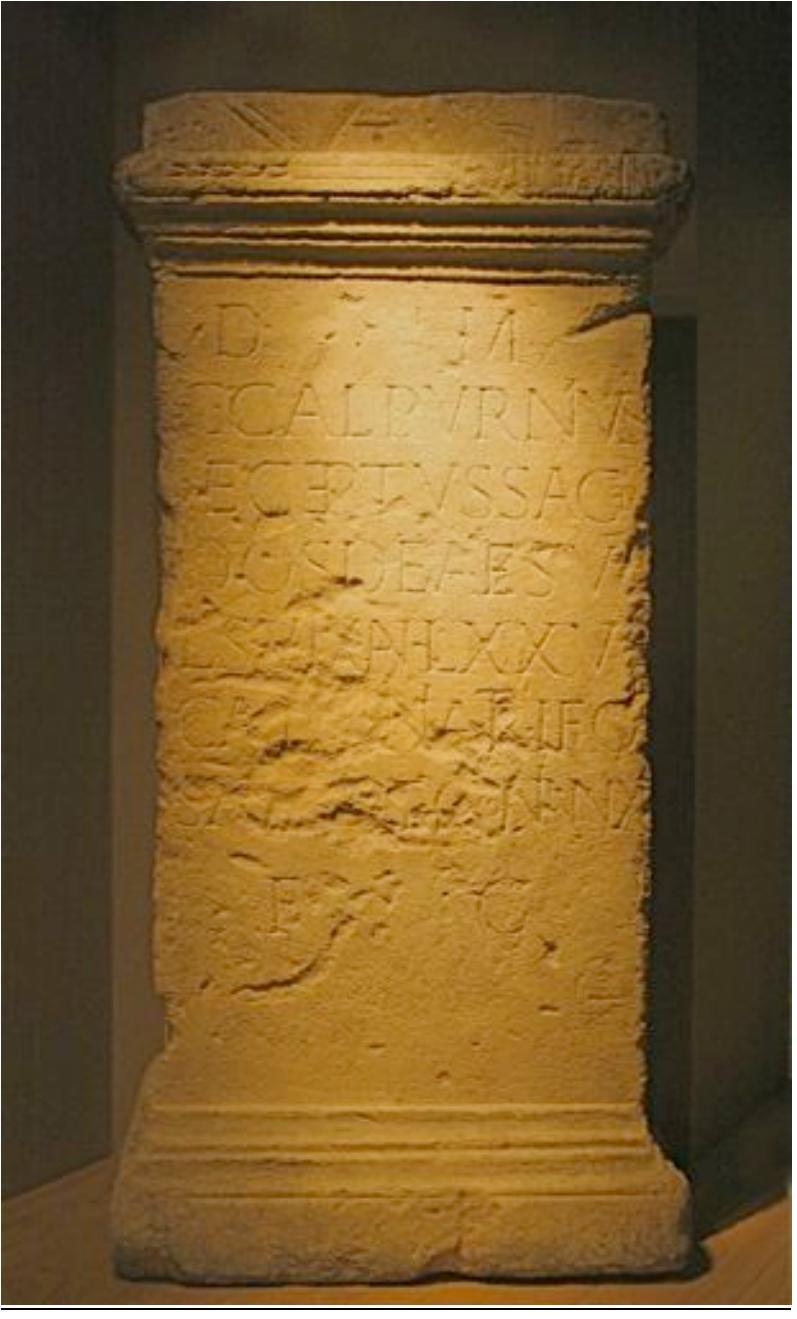
<u>1986.5.1 Calpurnus</u>

Relief moved from display and fixed on into new position on plinth. Object Vacuum cleaned.

Thick "C" section Steel braces fixed with expanding bolts into plinth

Check bolts for tightness and annual vaccum clean.

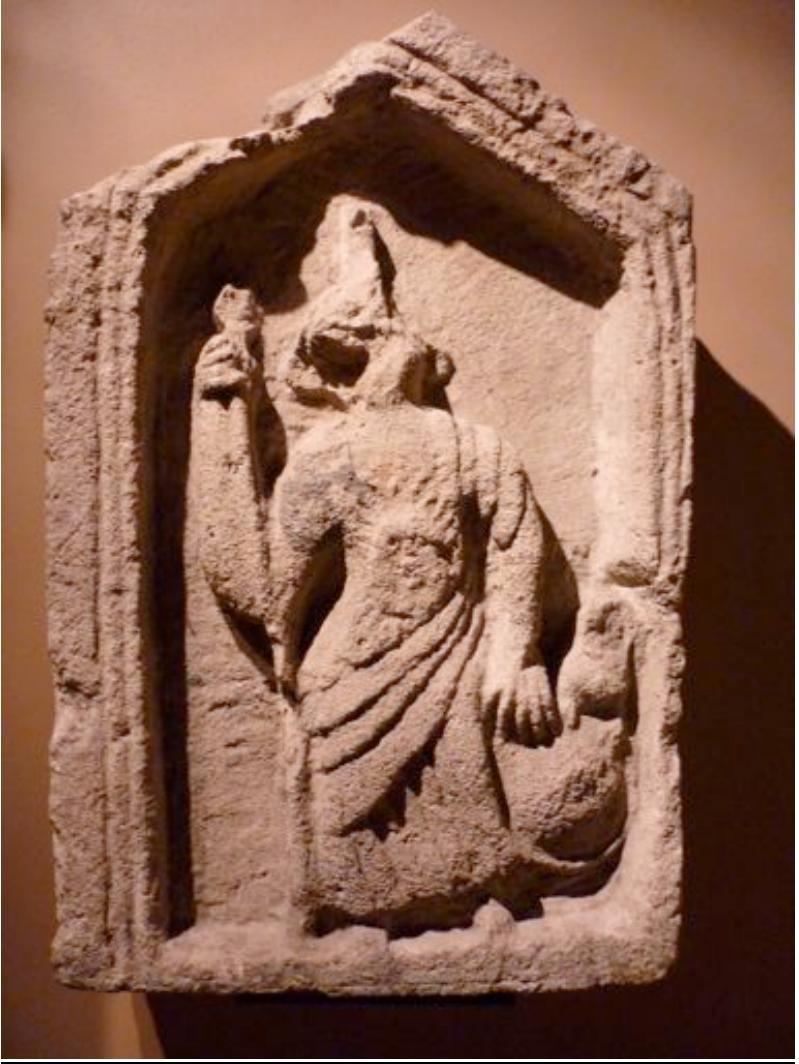
1983.2.5 Stone relief of Minerva

Relief moved from display and fixed into new wall position. Object Vacuum cleaned.

Stainless steel flat bar, felt cushion (fixed around the body of the stone) seated on unequal angle- iron bracket.

None apart from yearly vaccum.

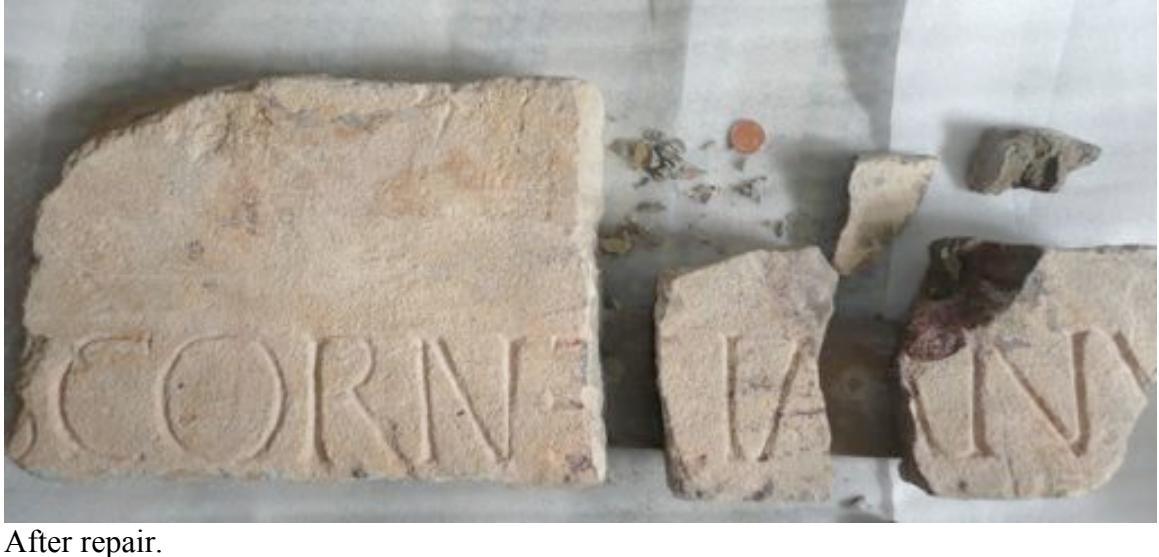
1986.6.4 Cornelianus Stone

Relief moved from storage and sat on into new position on wall. Inappropriate Cementitious repairs removed and ferrous pins removed and replaced with Stainless and a matched lime mortar. Object Vacuum cleaned.

The object sits on a 8mm equal angle plate bolted to the wall and restrained (using existing fixing points/holes) with Stainless flat bar.

None apart from annual vaccum (as fixings are now covered with wall finishes).

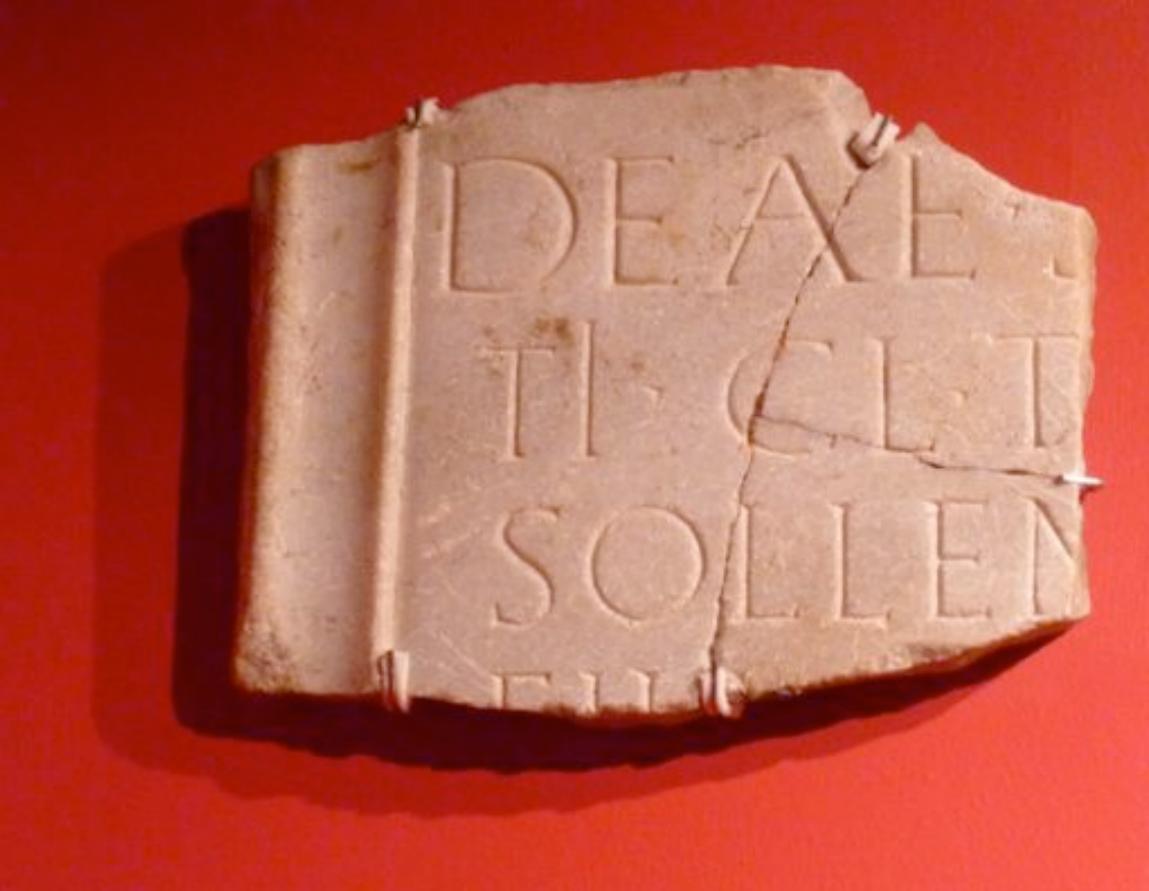
Sollemnis marble inscription

Inscription moved from storage and fixed on into new position on wall. 2. Fixings used.

The object sits on a 1.5mm rigid wird bolted to the wall and restrained (using existing fixing points such as cracks).

None apart from annual vaccum.

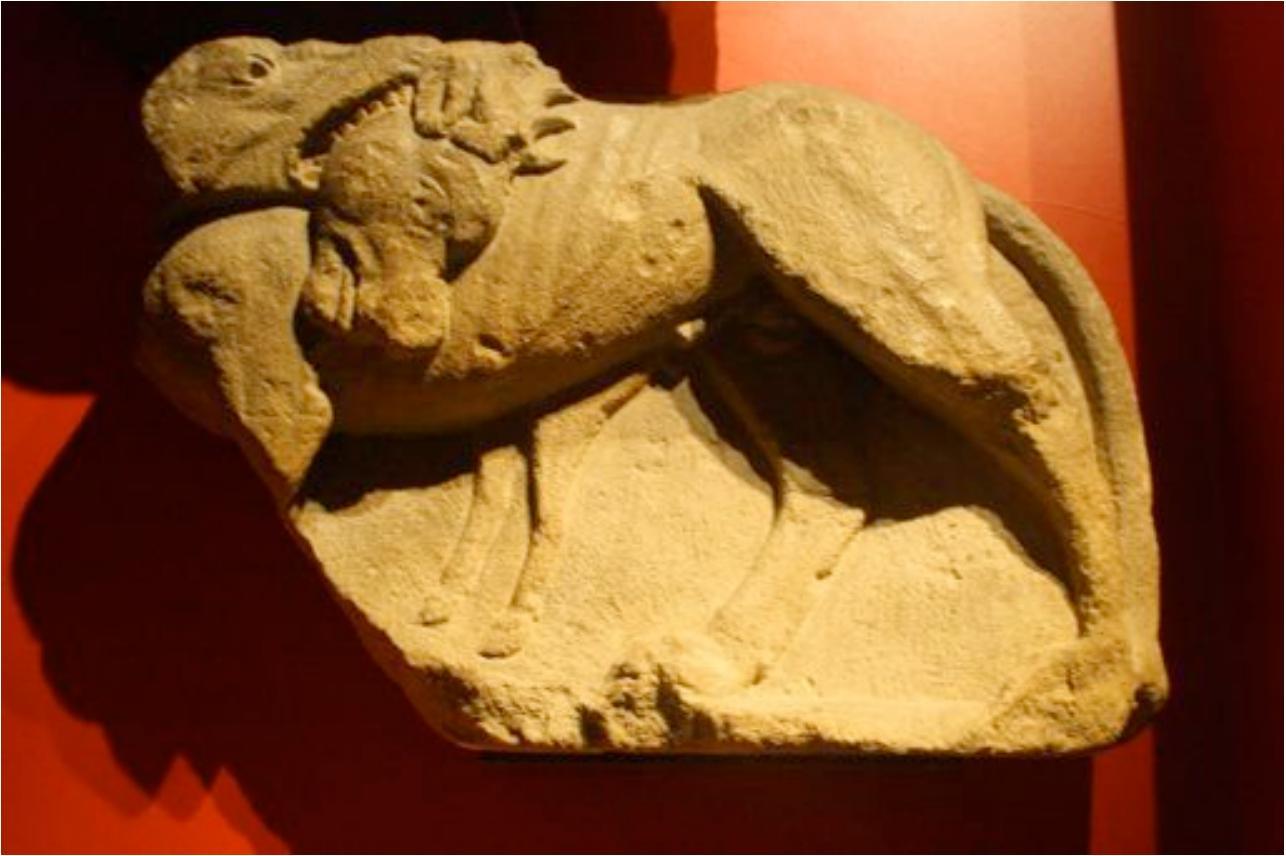
1986.5.16 Relief of dog carrying Roe deer

Relief moved from storage and sat on into new position on wall. Object Vacuum cleaned.

The object sits on a 8mm equal angle plate bolted to the wall and restrained (using existing fixing points/holes) with Stainless flat bar.

Old metal fixings still project from the rear of the relief.

None apart from annual vaccum (as fixings are now covered with wall finishes).

Test for stability every year.

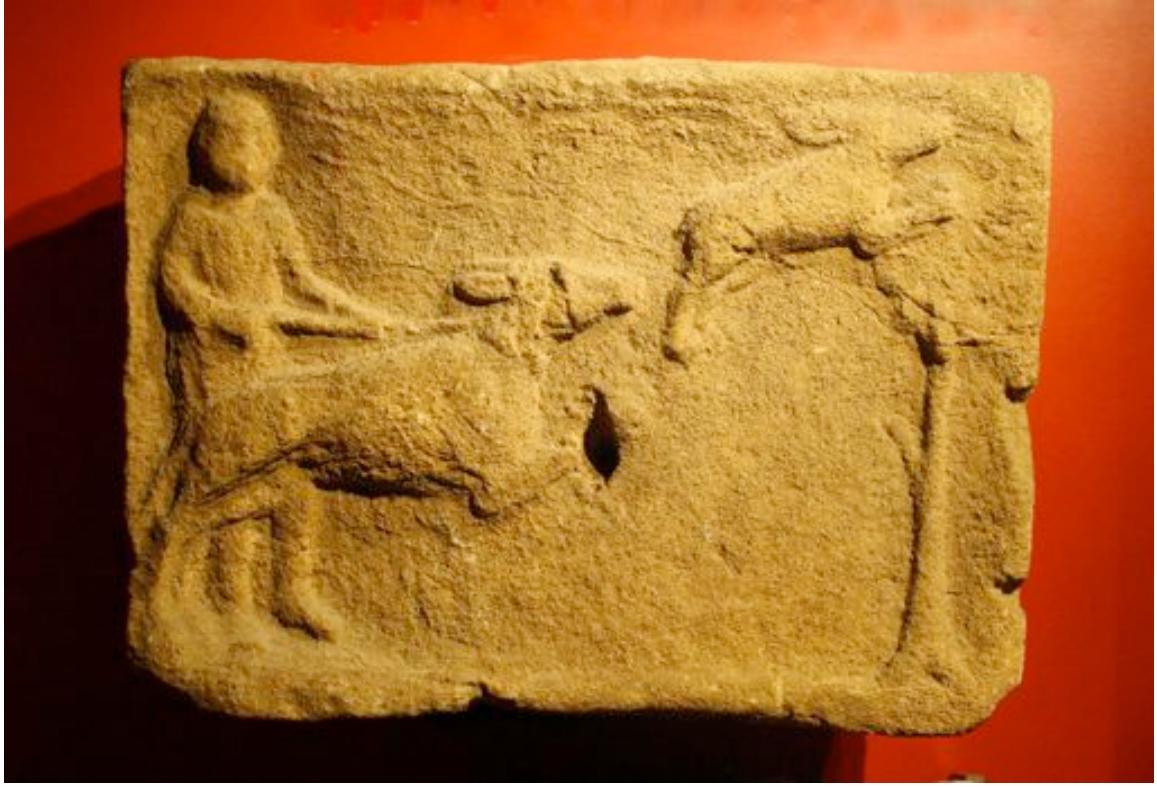
1986.2 Relief of hound chasing Hare

Relief moved from storage and sat on into new position on wall. Object Vacuum cleaned.

The object sits on a 8mm equal angle plate bolted to the wall and restrained (using existing fixing points/holes) with Stainless flat bar.

None apart from annual vaccum (as fixings are now covered with wall finishes).

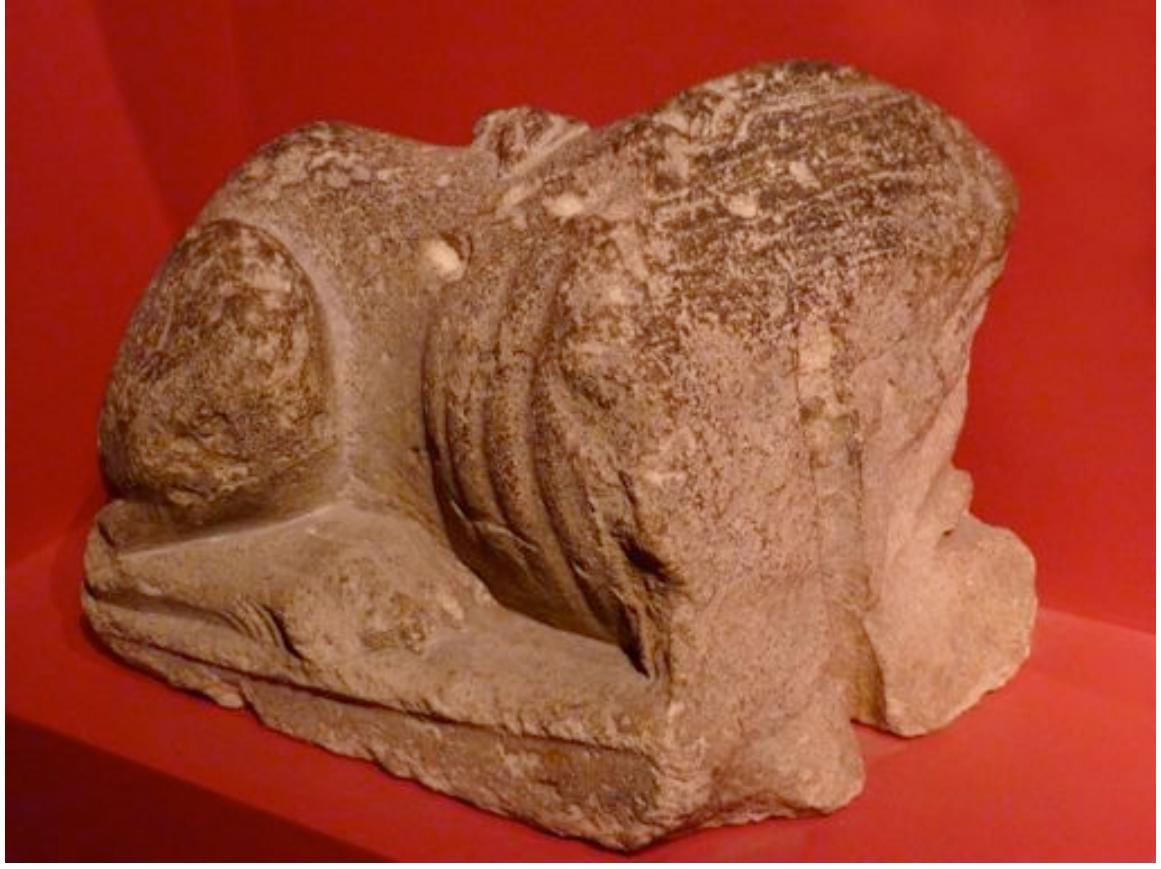
1981.654 Headless Lion

Relief moved from storage and sat on into new position on wall. Object Vacuum cleaned.

The object sits unfixed on plinth

None apart from annual vaccum

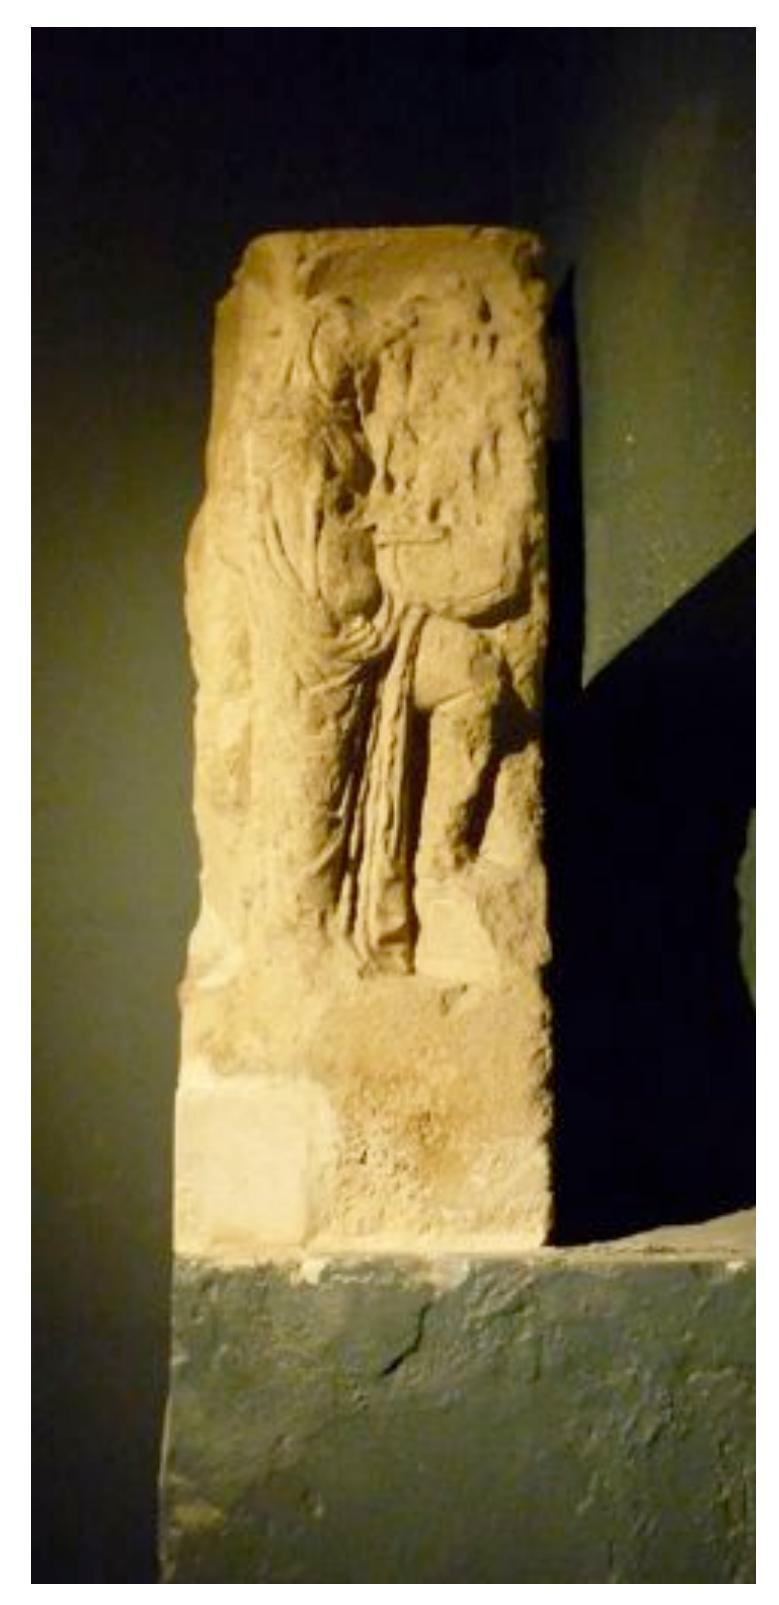
1983.1.29 Compton Dando Altar stone.

The Altar stone was moved from original position and sat on into new position on top of wall in Temple Precinct. Recent stone support adjusted to fit new space. Object Vacuum cleaned. 2. Fixings used. The object is self supporting and sits on a pad of putty lime Mortar. 3. Future maintenance/conserva tion requirements. None apart from annual vaccum (as fixings are now covered with wall finishes). 4. Potential future risks and considerations.

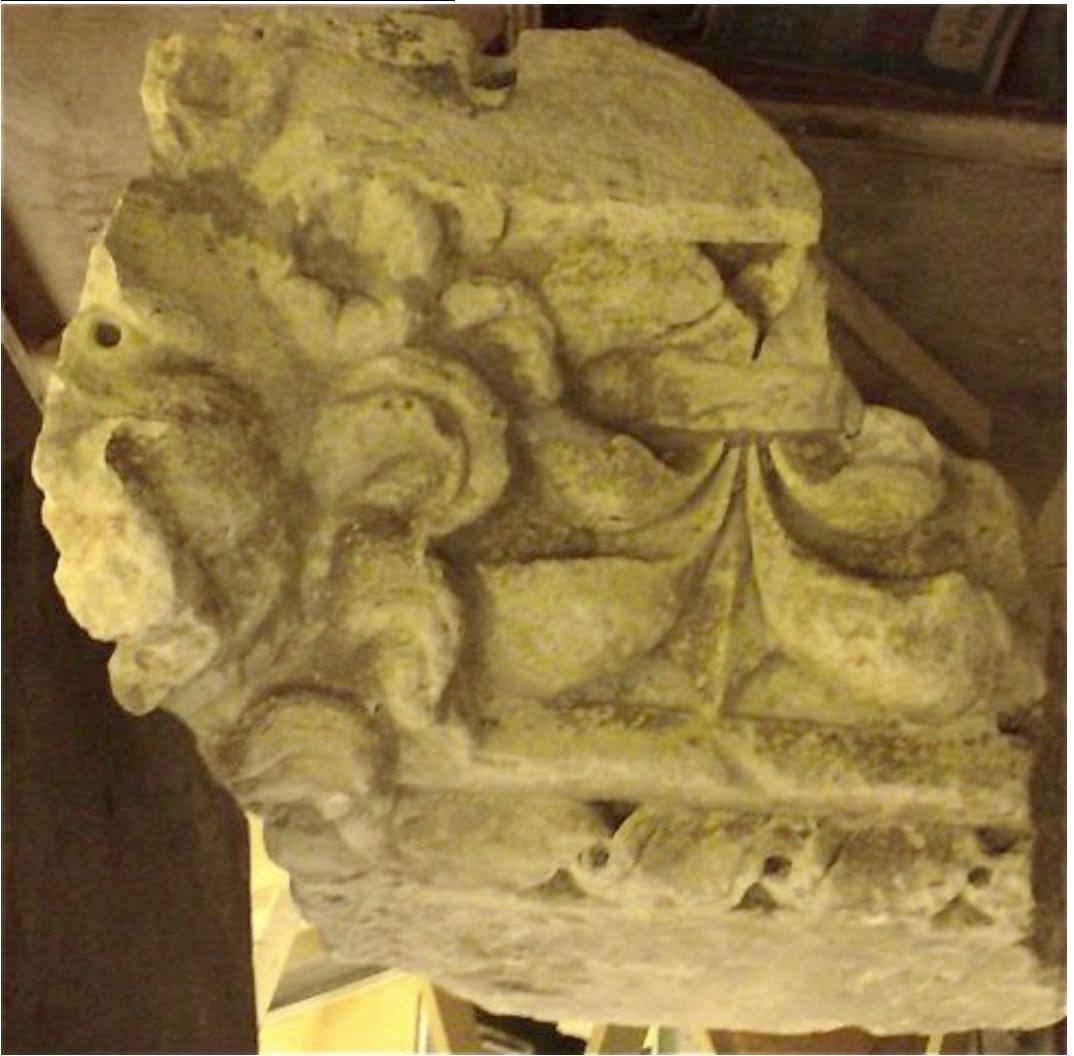
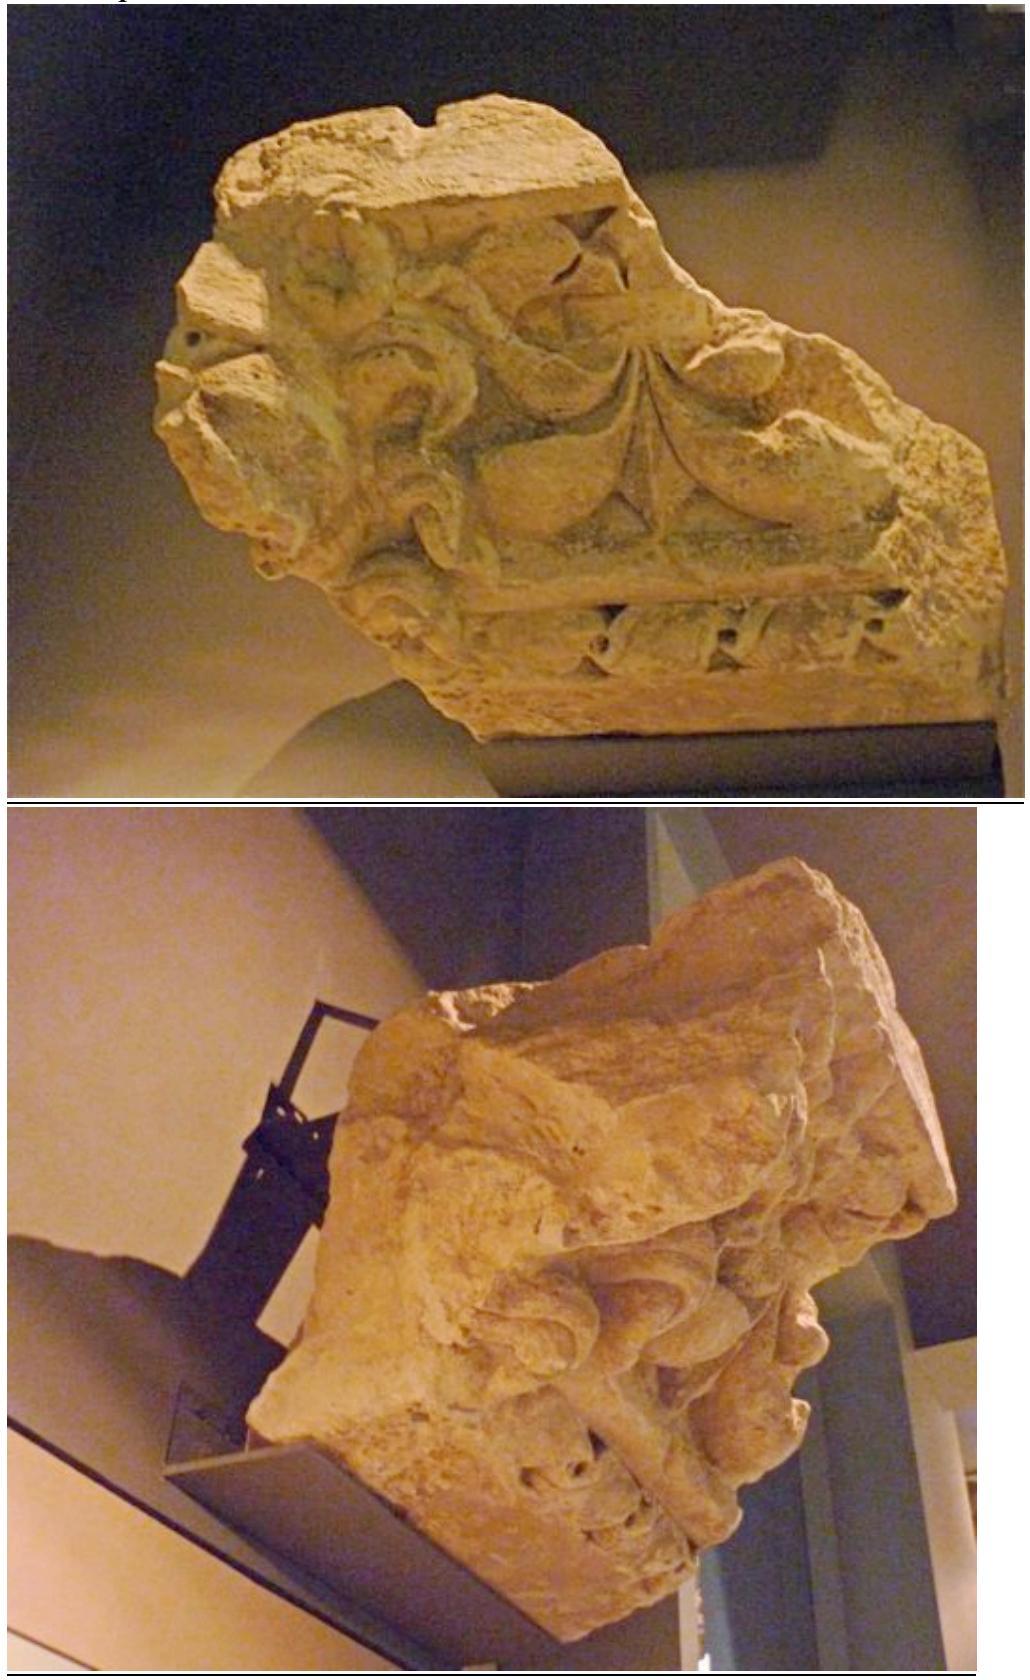
1983.3.1 Medusa Cornice

Relief moved from storage and sat on into new position on wall. Object Vacuum cleaned.

The object sits on a 10mm unequal angle plate bolted to the wall and restrained with a pre-fabricated support bracket, permission was granted to drill 2 additional holes to assist with fixing (in the absense of existing fixing points) and consolidation of 2 seperated elements. Mortar repairs were undertaken.

Move seat that sits underneath as the condition of historic repairs cannot be assessed.

Inspect fixings and vaccum annually.

Test for stability every year.
