<u>Health and Safety file. Roman Baths Development</u> <u>Project</u>

Observations and catalogue relating to Conservation work undertaken, fixings used, information for future residual risks and safe systems of work for future moves.

MINERVA STONE CONSERVATION

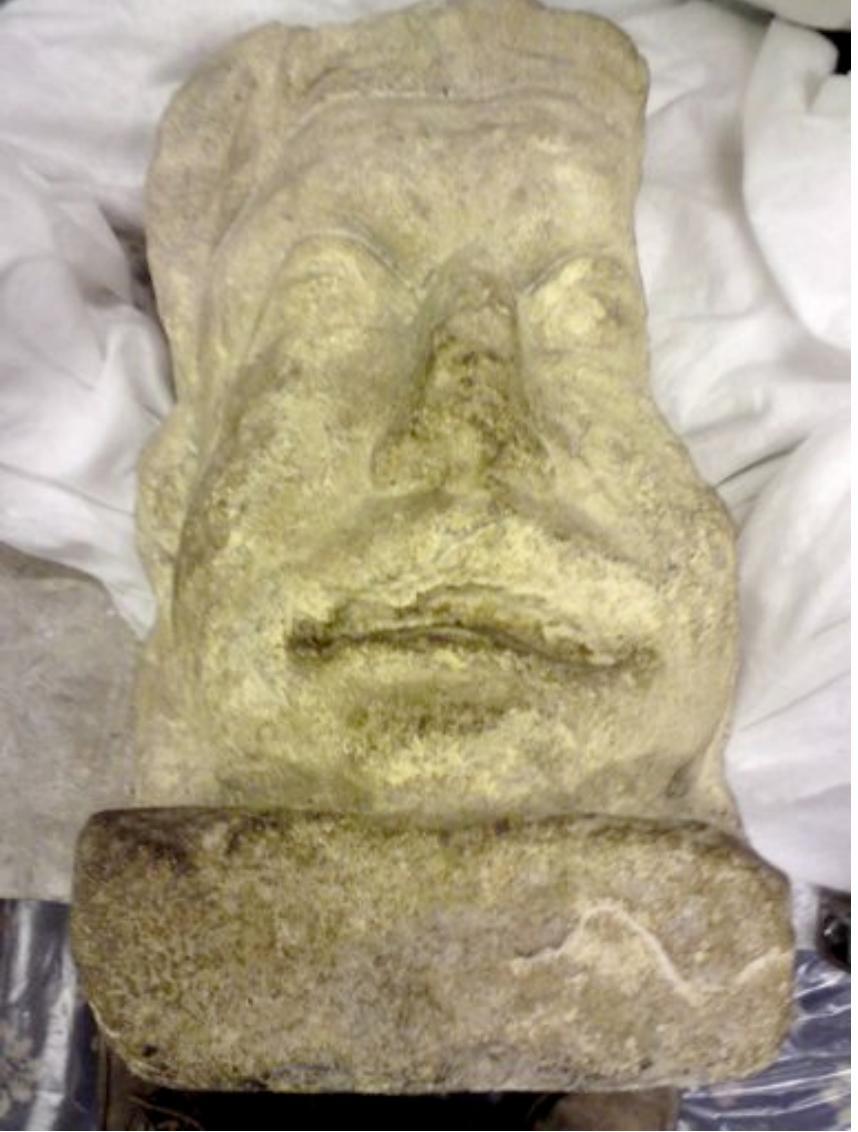
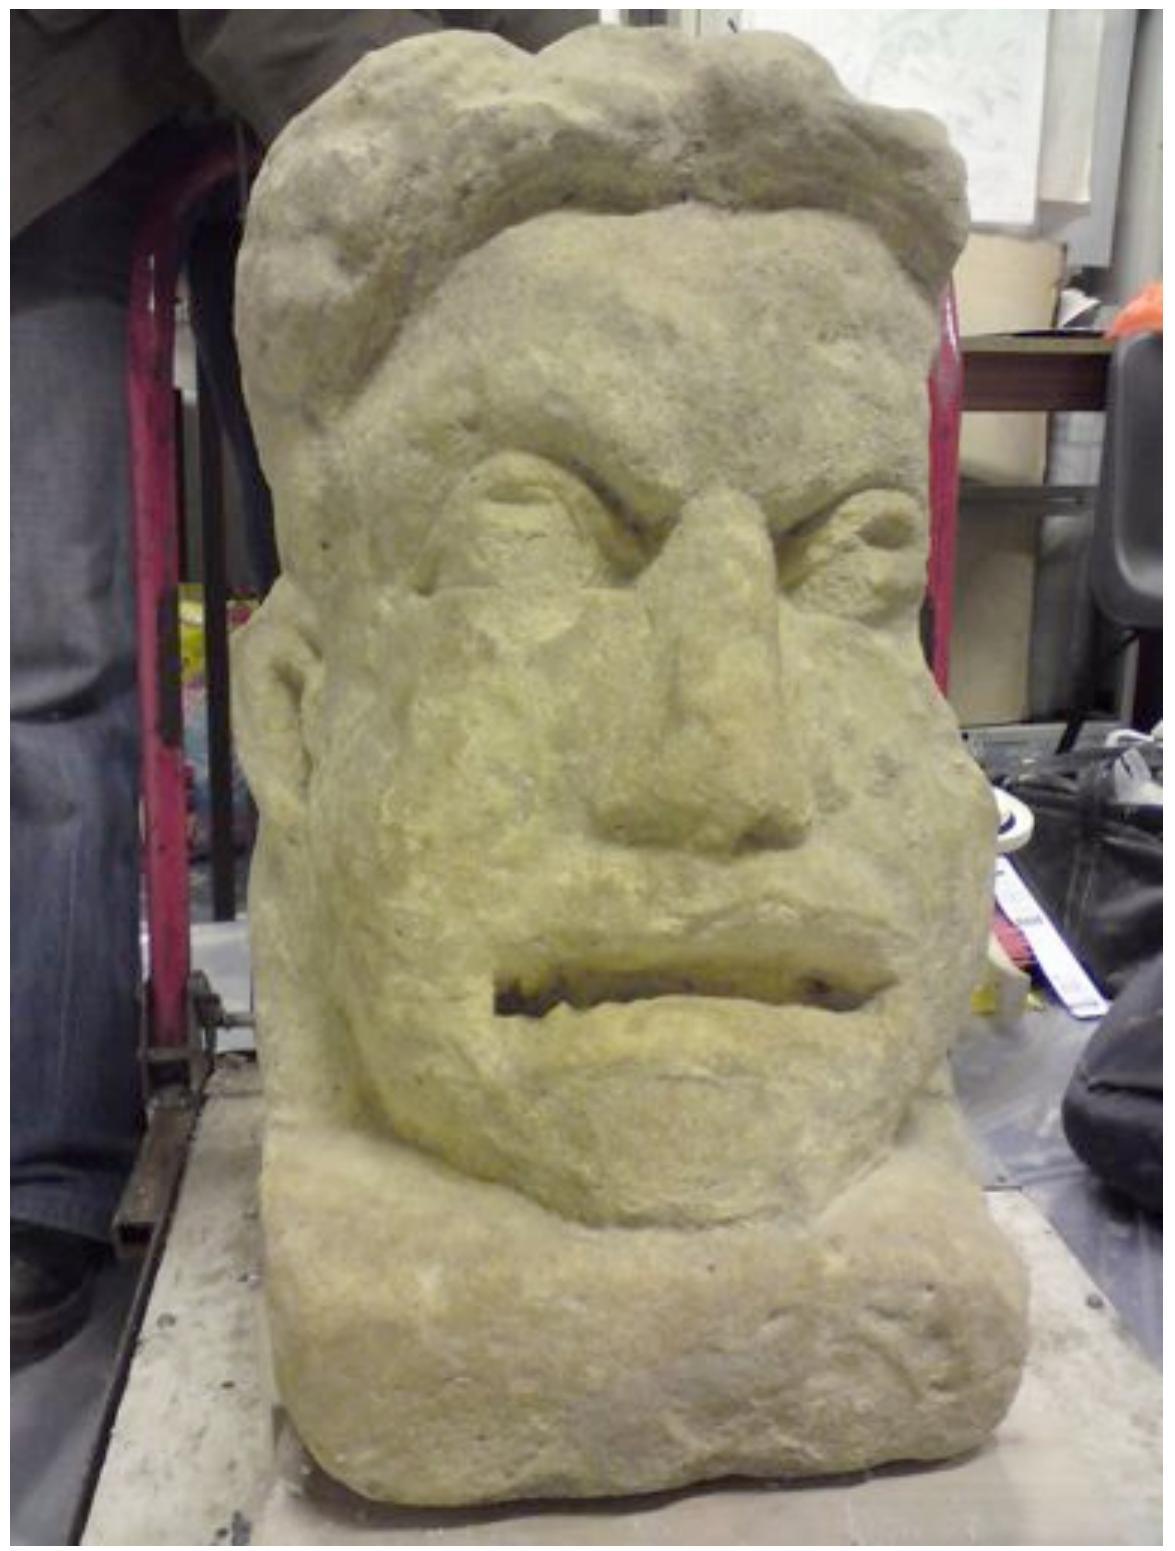
<u>1986.5.15 Theatrical mask.</u> Before dirt removal

Mask moved from storage and sat on into new position on plinth. Object cleaned with the aid of Ammonium Carbonate Poultice (Acid free paper pulp)

The object sits on a 10mm unequal angle plate bolted to the wall and restrained (using existing fixing points/holes.

After cleaning.

None apart from annual vaccum (as fixings are now covered with wall finishes).

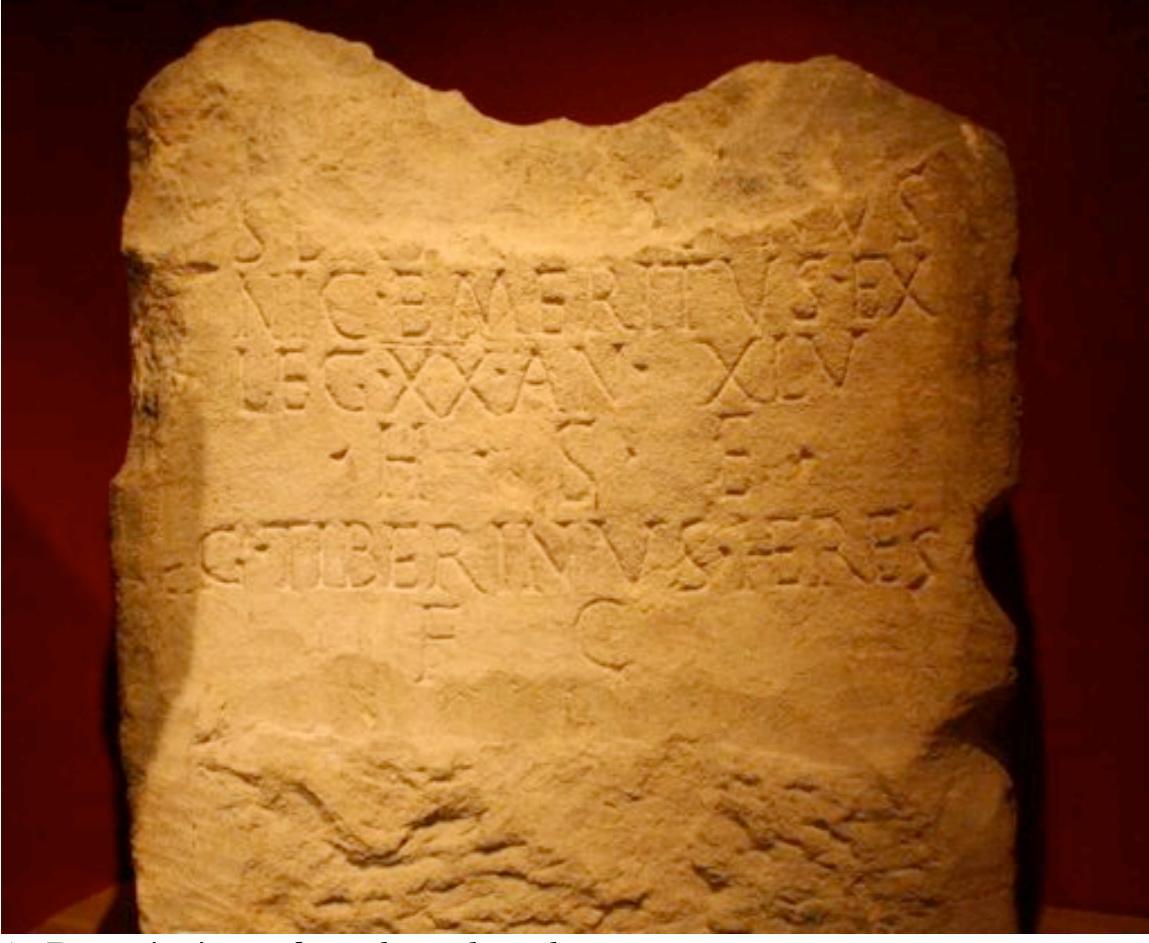
1986.5.7 (Antigonus)

Relief moved from display and fixed on into new position on plinth. Object Vacuum cleaned.

Thick "C" section Steel braces fixed with expanding bolts into plinth and pre existing holes in stone.

Check bolts for tightness and annual vaccum clean.

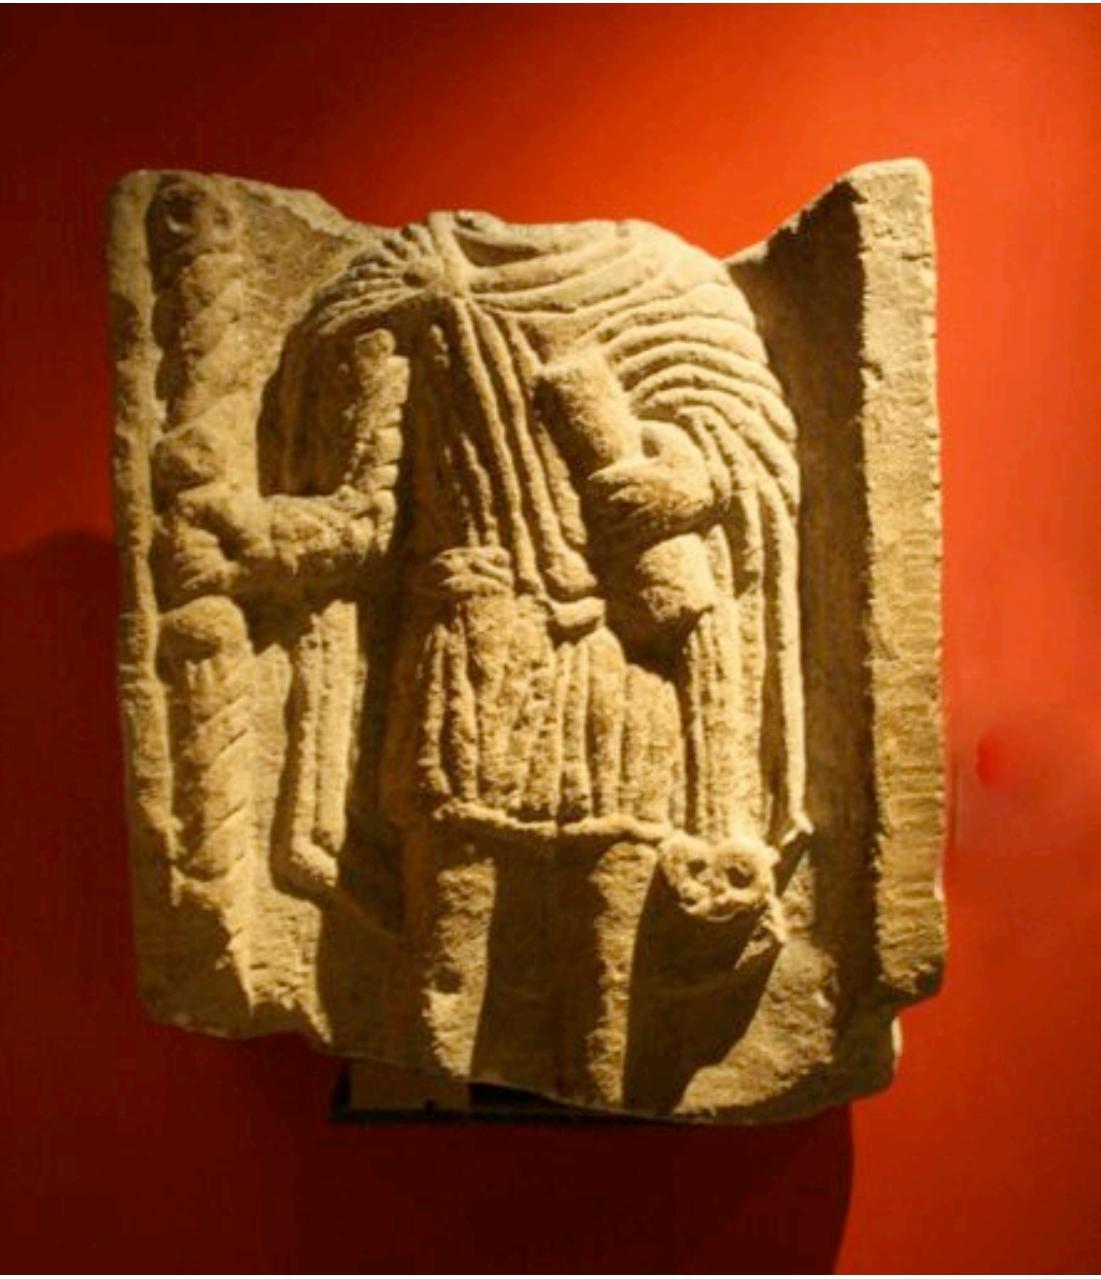
1986.5.17 Short tunic relief

Relief moved from storage and sat on into new position on wall. Object Vacuum cleaned.

The object sits on a 8mm equal angle plate bolted to the wall and restrained (using existing fixing points/holes) with Stainless flat bar.

None apart from annual vaccum (as fixings are now covered with wall finishes).

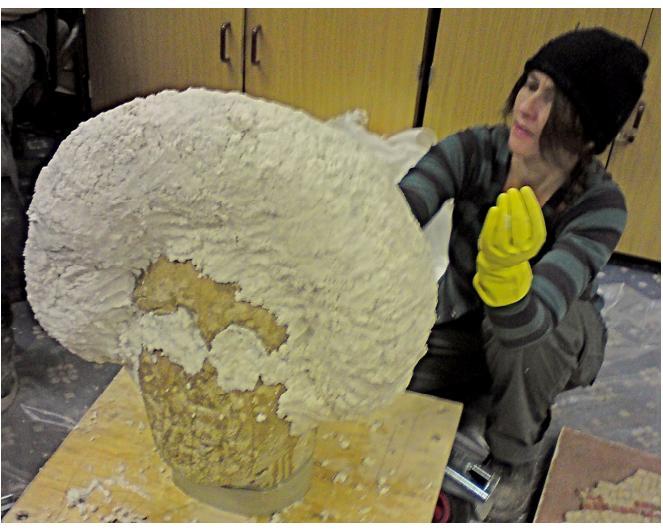
1986.5.14 Flavian Ladies Head.

Head moved from storage and sat on into new position on plinth. Object cleaned with the aid of Ammonium Carbonate Poultice (Acid free paper pulp).

The object sits on a 18mm Dowell on plinth.

None apart from annual vaccum clean.

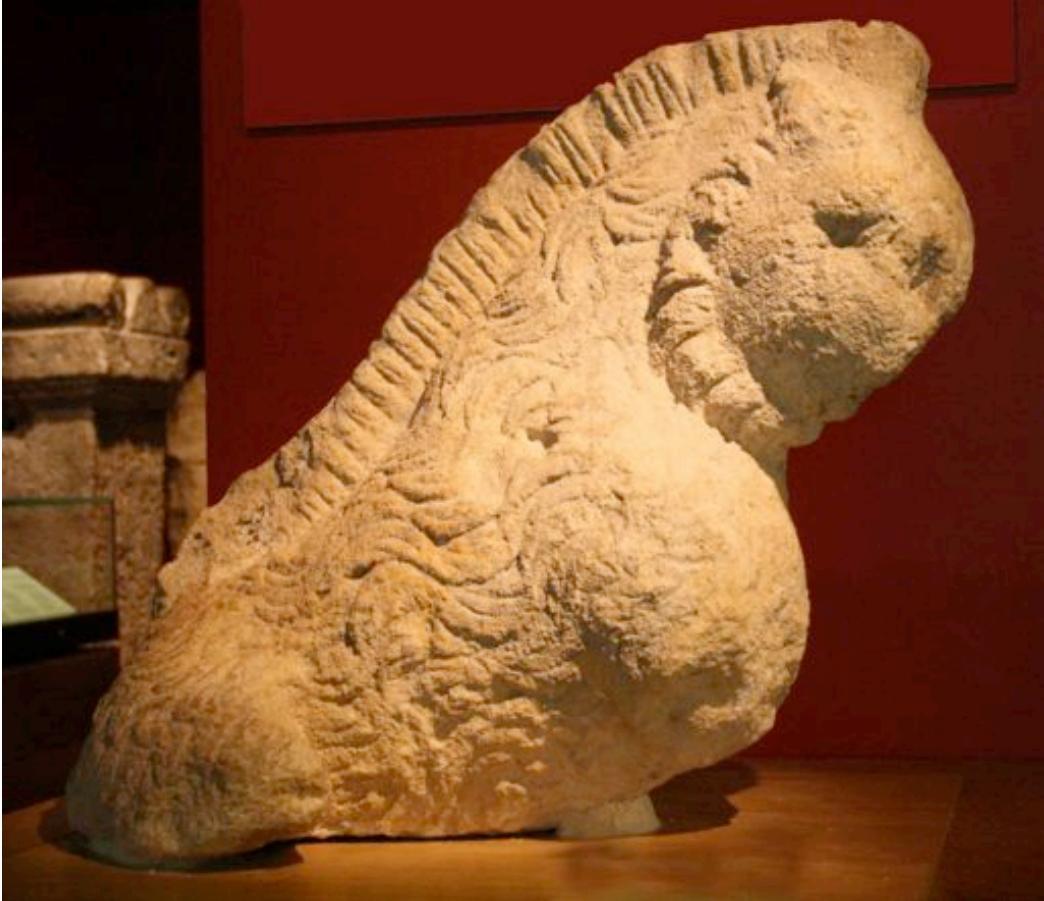
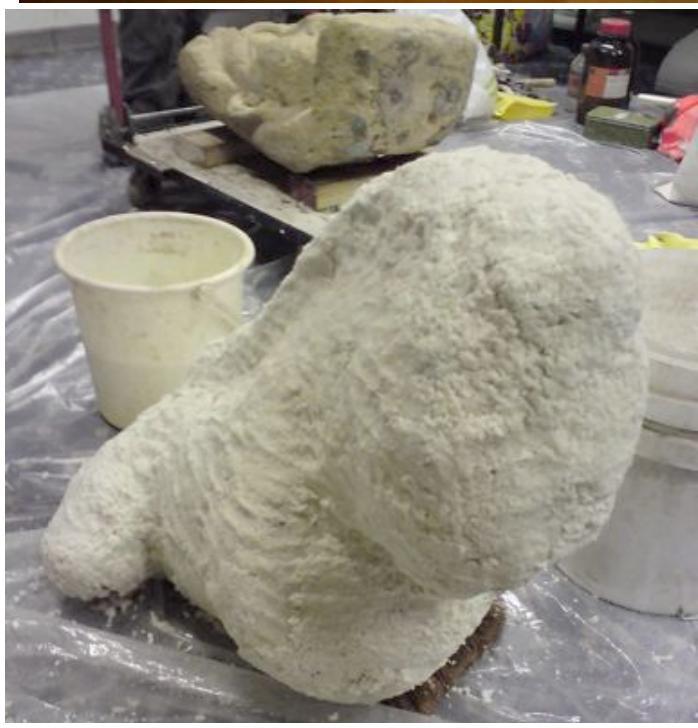
1983.2.8 Sculpture of Boar.

Boar moved from storage and sat on into new position on plinth. Object cleaned with the aid of Ammonium Carbonate Poultice (Acid free paper pulp)

The object sits on Lime mortar fillet.

None apart from annual vaccum.

Test for stability every month.

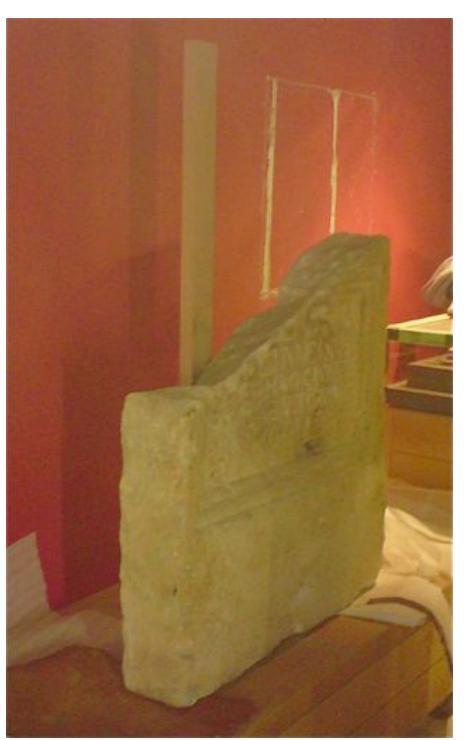
1986.5.5 Vitellius Mantai.

Relief moved from display and fixed on into new position on plinth. Object Vacuum cleaned.

Thick "C" section Steel braces fixed with expanding bolts into plinth and pre existing holes in stone.

Check bolts for tightness and annual vaccum clean.

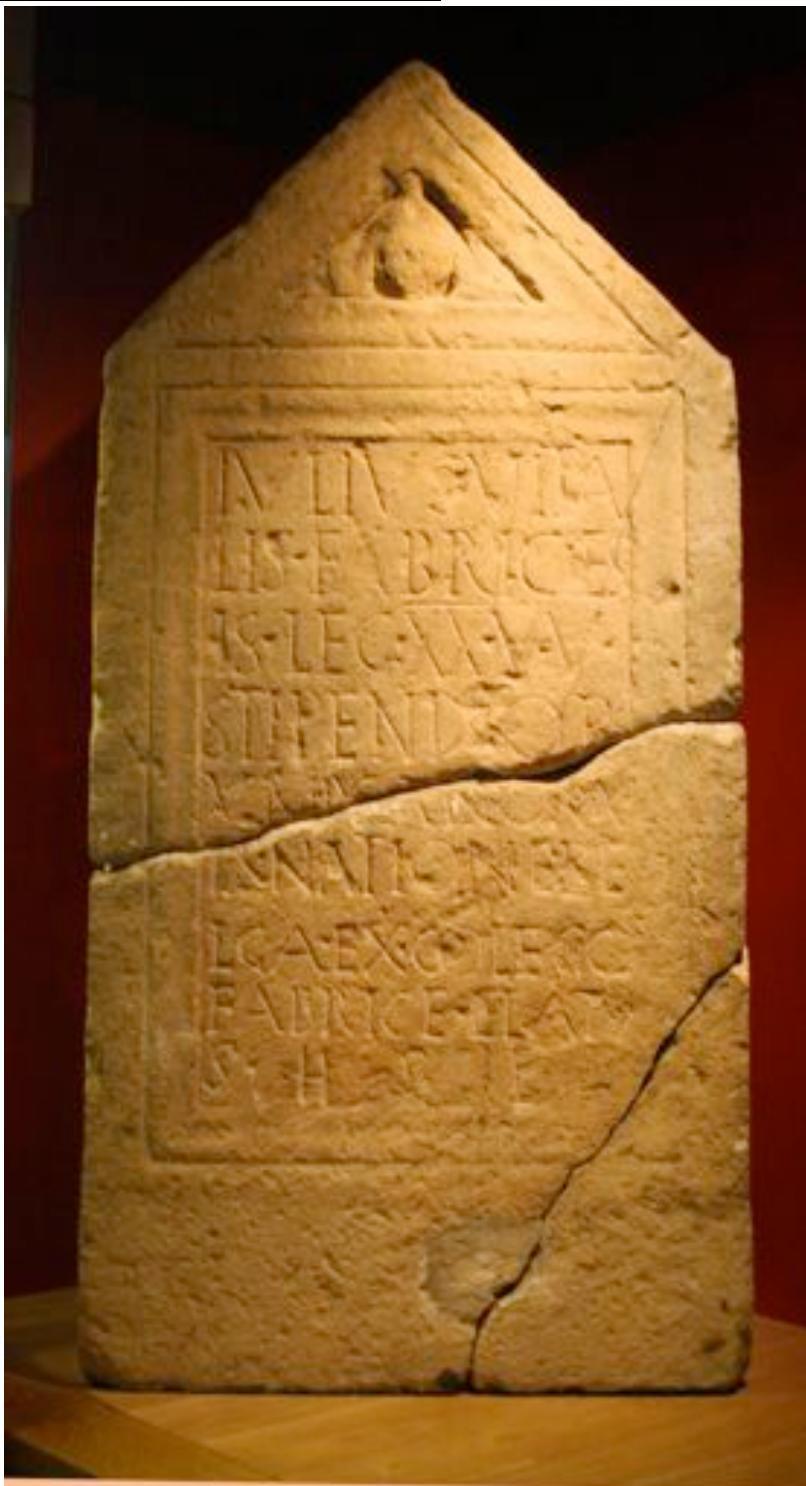
1986.5.2 Julius Vitalis

Relief moved from display and fixed on into new position on plinth. Object Vacuum cleaned.

2. Fixings used.
Thick "C" section
Steel braces fixed
with expanding
bolts into plinth
and pre existing
holes in stone.
3. Future

4. Potential future risks and considerations. Test for stability every year. Bottom

maintenance/co nservation requirements. Check bolts for tightness and annual vaccum clean.

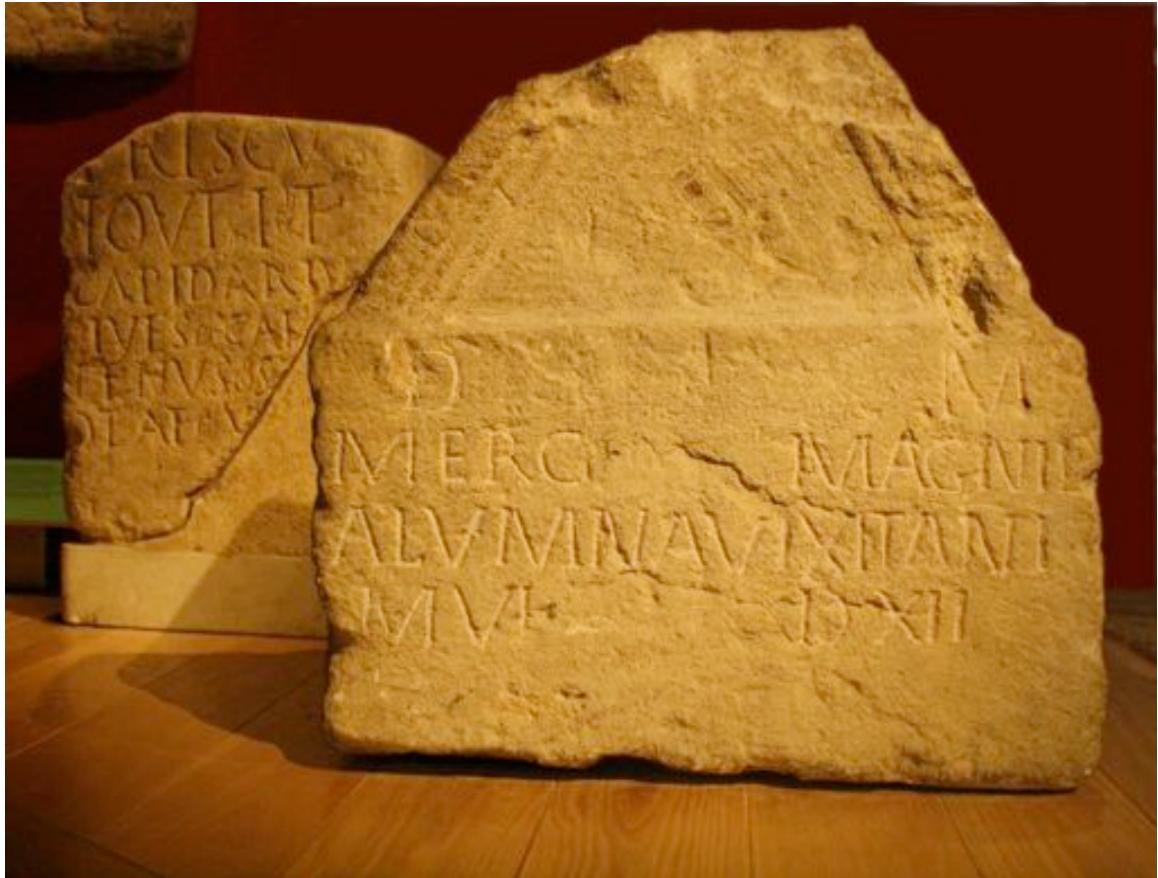
Reliefs moved from storage and sat on into new position on plinth. Object Vacuum cleaned.

Priscus sits unfixed on plinth, Merc Magni has additional Stainless Support bracket fixed to its rear side.

None apart from annual vaccum

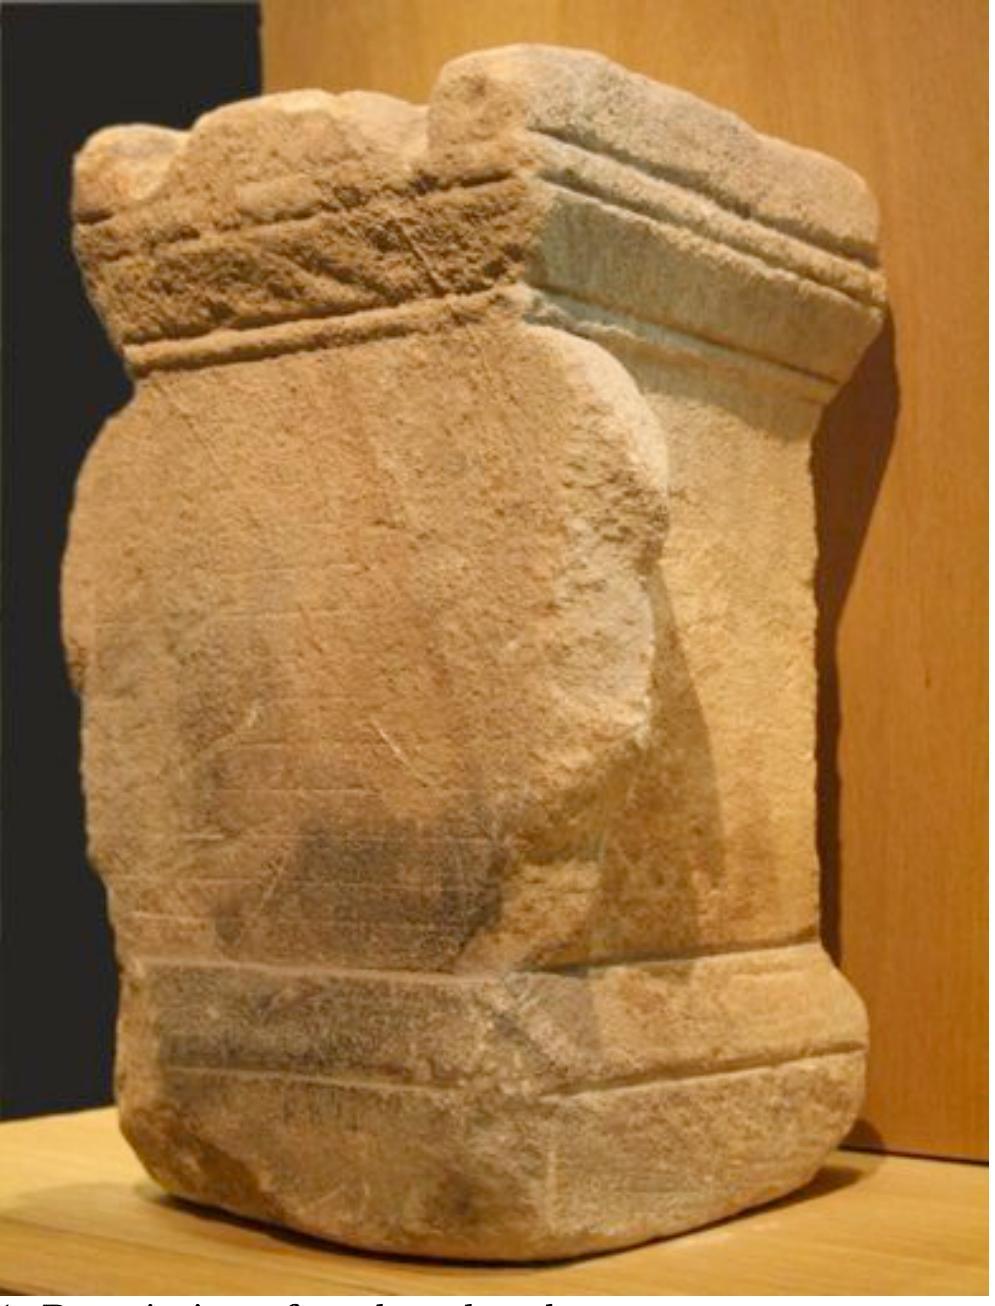
RB14 Bathwick Altar

Relief moved from storage and sat on into new position on wall. Object Vacuum cleaned.

The object sits unfixed on plinth

None apart from annual vaccum

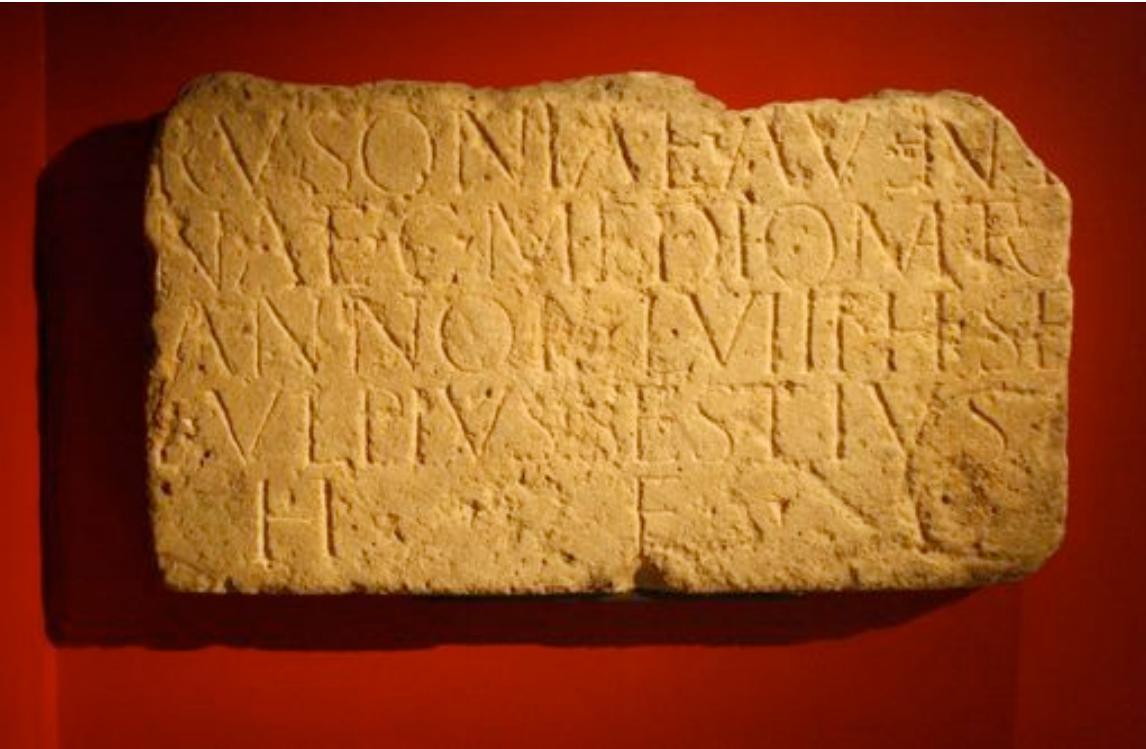
1986.5.10 Rusonia Aventina.

Relief moved from storage and sat on into new position on wall. Object Vacuum cleaned.

The object sits on a 8mm equal angle plate bolted to the wall and restrained (using existing fixing points/holes) with Stainless flat bar.

None apart from annual vaccum (as fixings are now covered with wall finishes).

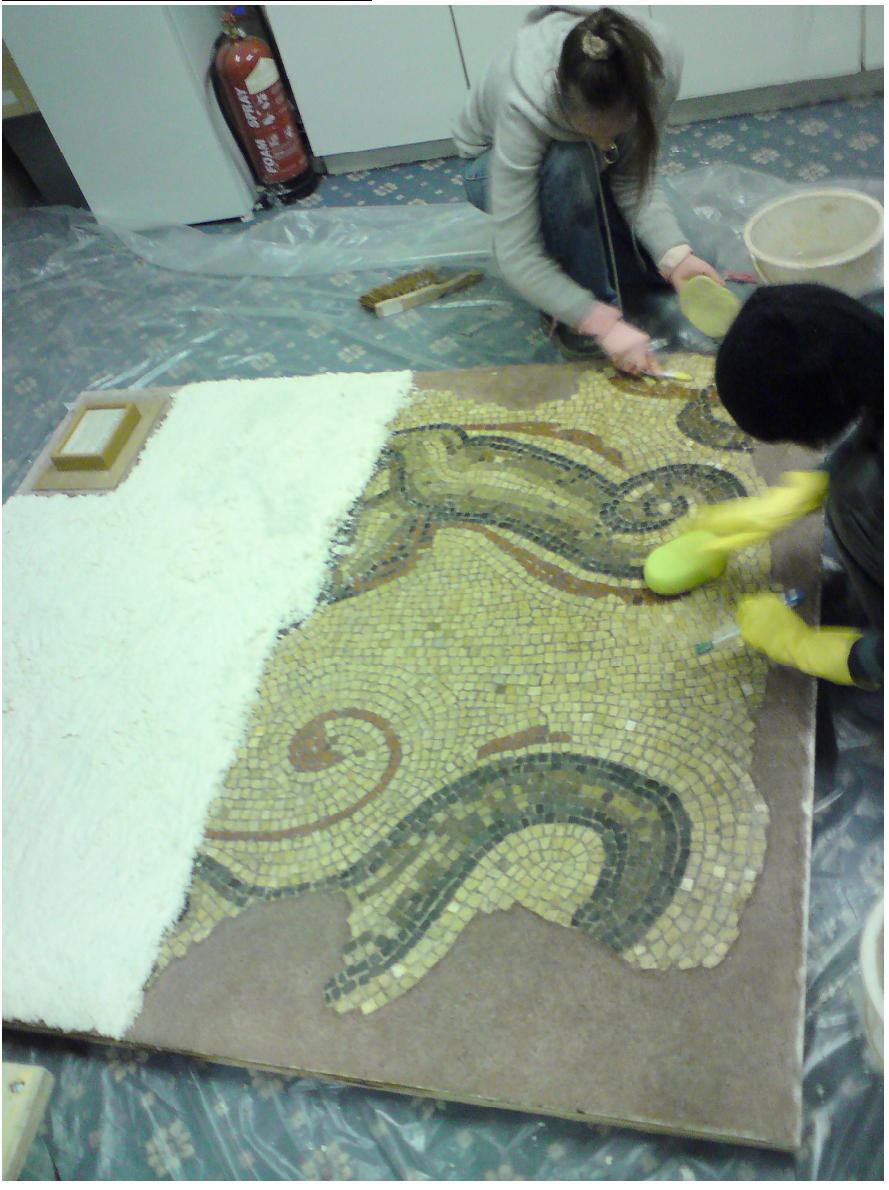
Sea Beasts Mosaic

Mosaic moved from storage and sat on into new position on plinth. Object cleamed with the aid of Ammonium Carbonate Poultice (Acid free paper pulp)

None

None apart from annual vaccum

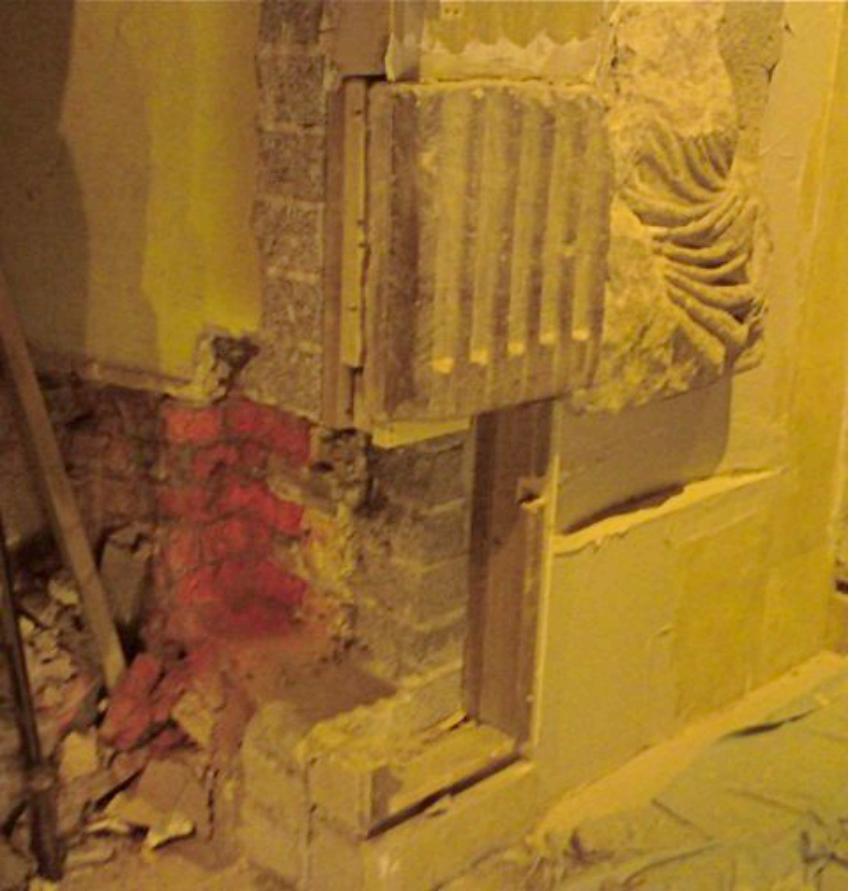
Work to Four Seasons Temple Façade.

Various stones moved from other positions on façade and fixed onto blockwork wall and made good.

The objects sit on 10mm unequal angle plate bolted to the wall and restrained (using existing fixing points/holes).

None apart from annual vaccum (as fixings are now covered with wall finishes).

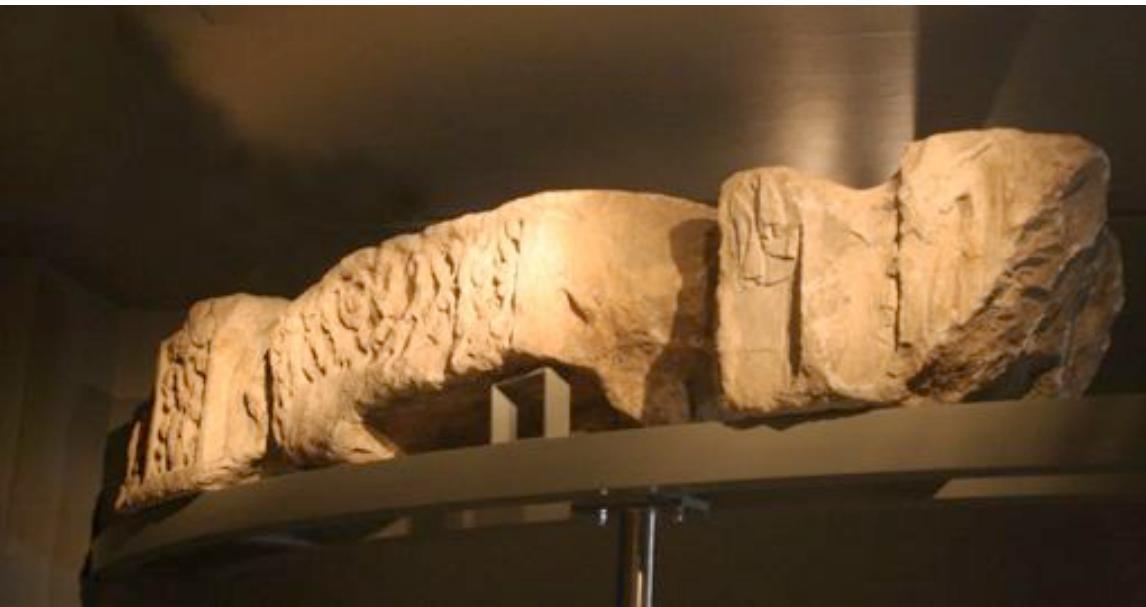
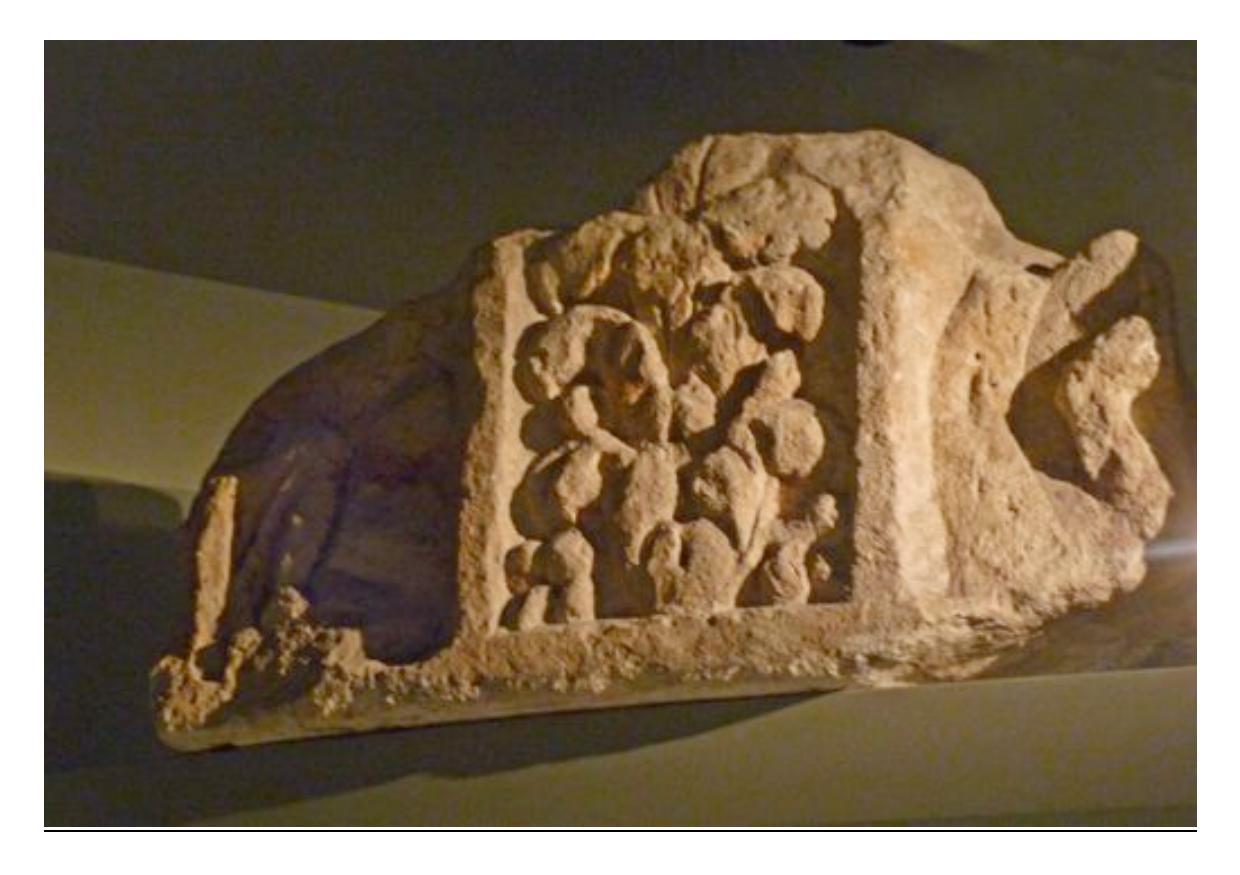
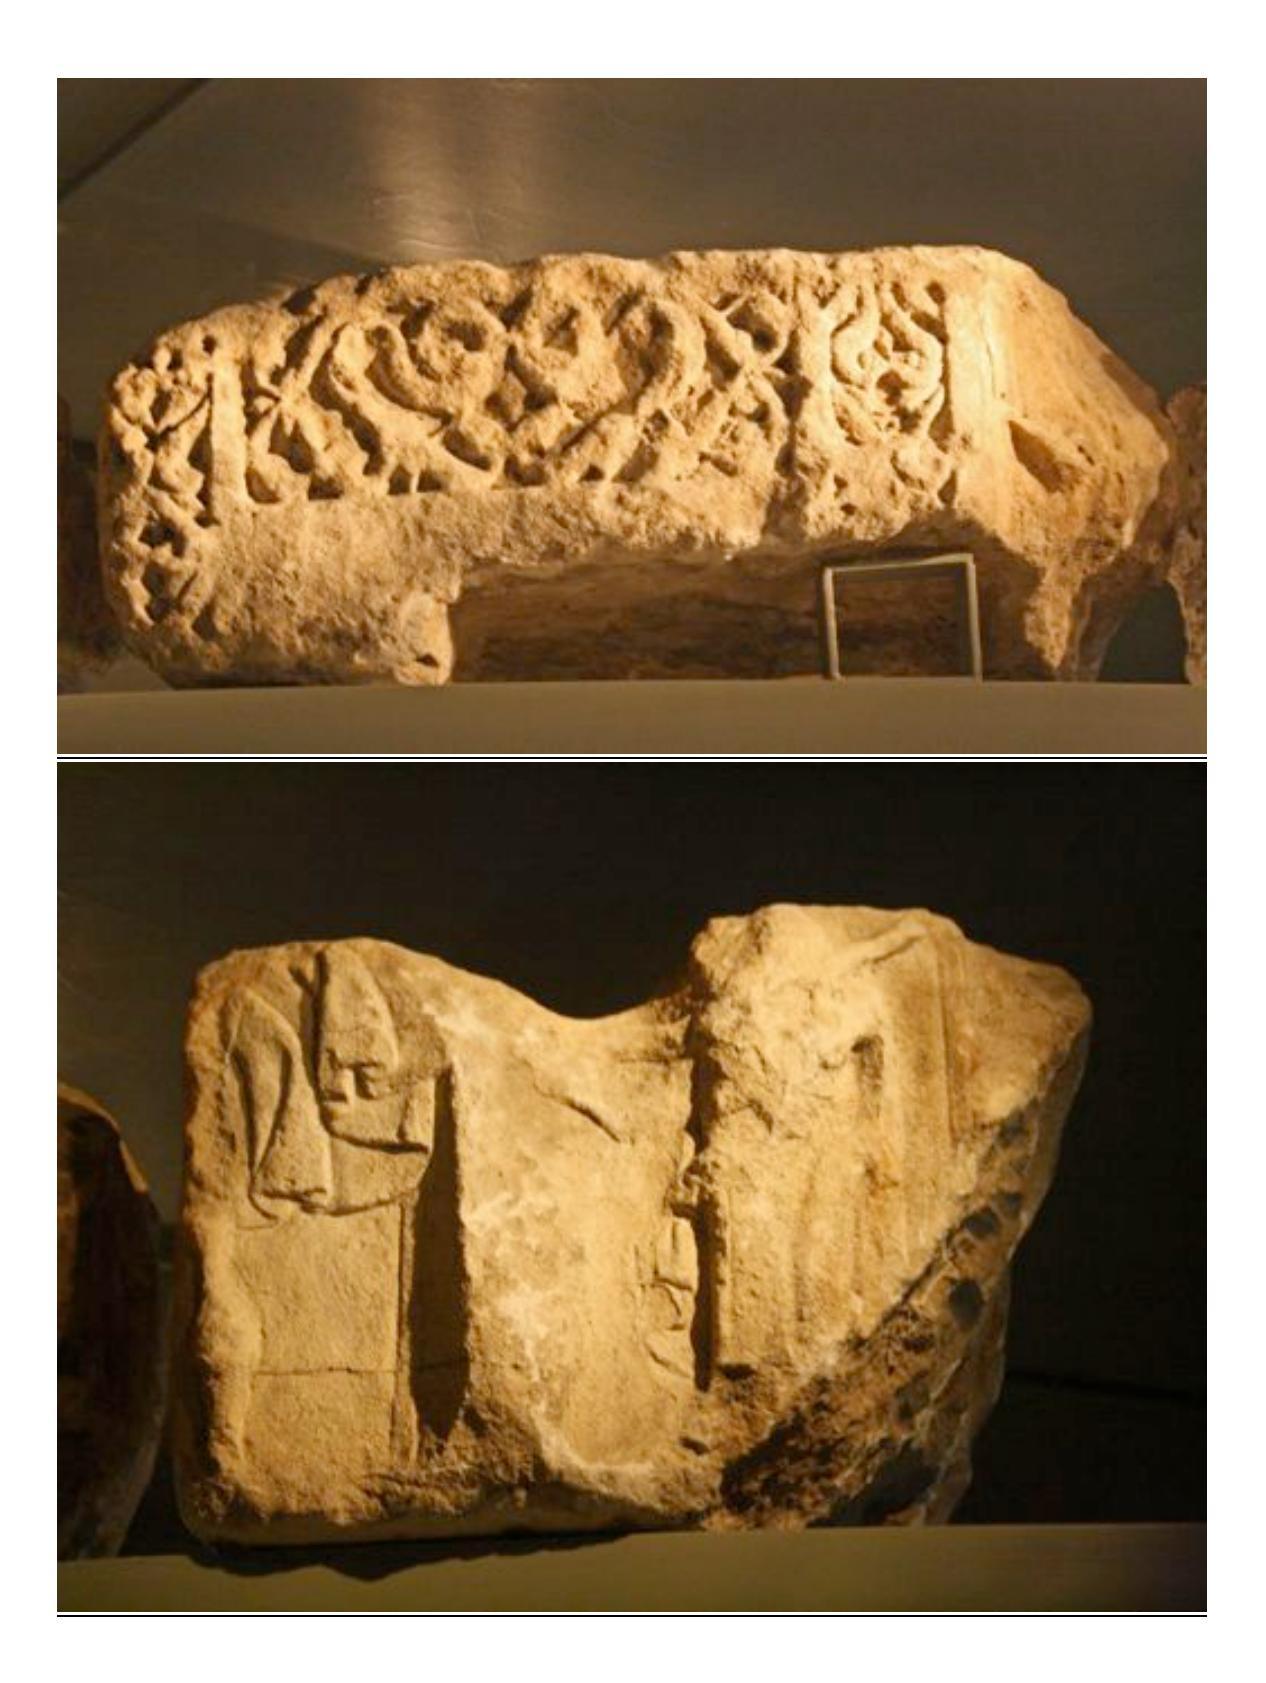
Movement of Tholos Stones. The Roman Baths, Bath, Somerset.

Tholos stones moved from storage and sat on into new position on raised platform.)

No fixings are used , apart from the square prop.

None apart from annual vaccum. Ensure that the overhang is equal on both sides of the support frame (about 30mm).

Test for stability every year.
