Tales from the riverbank.

Old bridges abound, though many are hidden by undergrowth. Some are being eroded by water, frost and traffic. Stone conservator and SPAB Fellow Andrew Ziminski tells of his own close encounters.

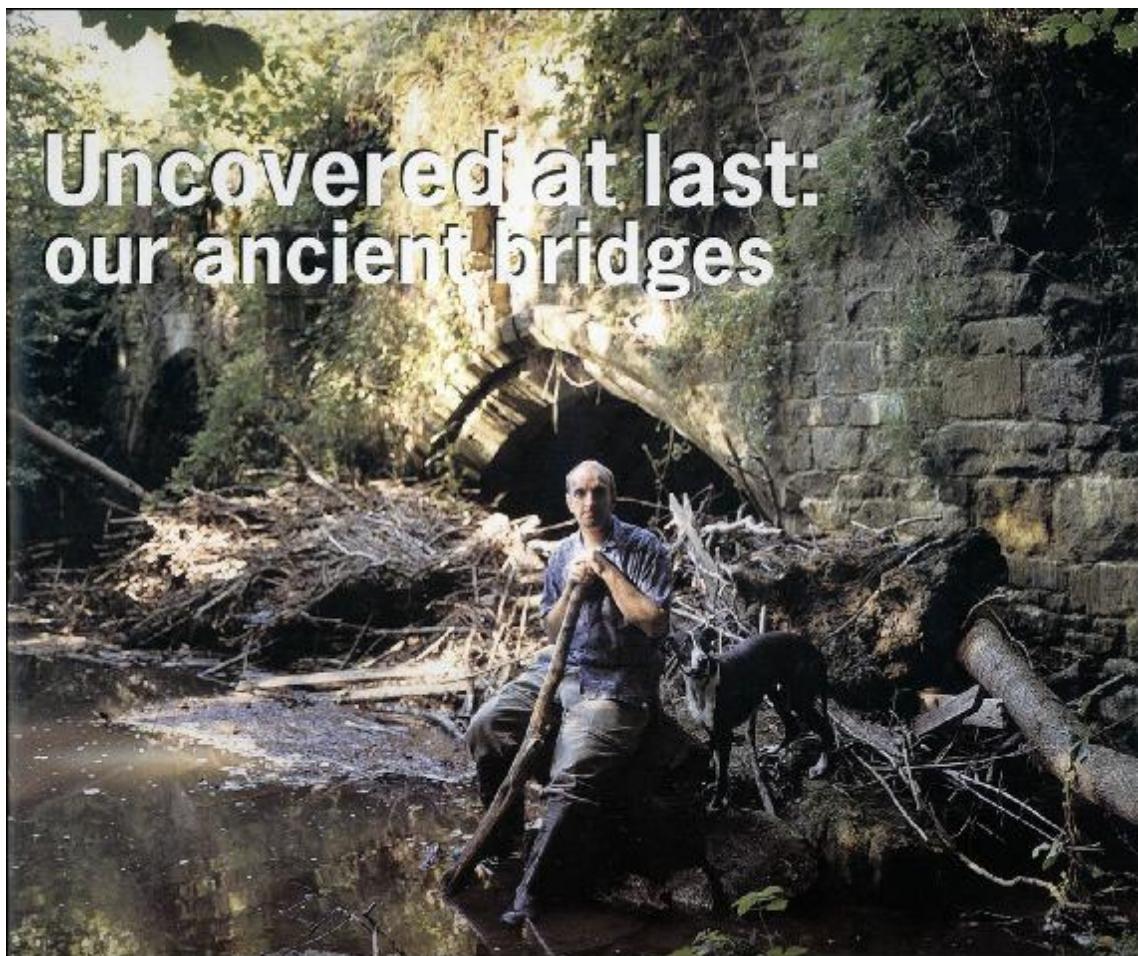
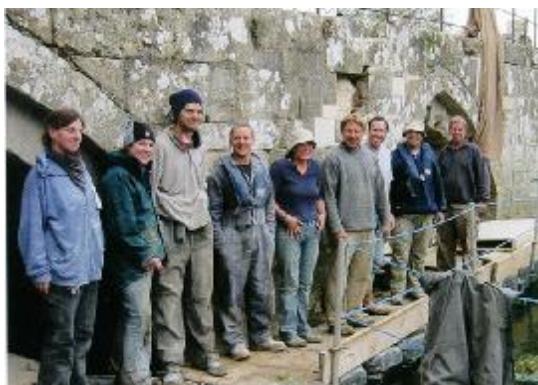
Above Andrew Ziminski at Murty's Aqueduct, built in the 1790s. The aqueduct is just upstream from 14th-century Murty's Packhorse Bridge Left, the Minerva Conservation team, friends and fellow travellers gather at Barton Farm Bridge.

We will soon be undertaking some basic structural repairs to the voussiors & Cutwaters of the lonely & now rather sad Murtrys Aqueduct of the long defunct & uncompleted Dorset & Somerset Canal which was planned to connect the Bristol and English Channels from Bath to Poole, via Wincanton & Frome, it dates from 1796 and was planned to carry coal and the locally produced products of Fussell's Iron and edged Tools over the Mells River.

A few hundred yards down stream sits Murtrys Packhorse bridge, essentially C14. two of the original three slightly pointed ribbed arches, remain, the bridge was widened in 1817 but became obsolete when the railway constructed a new bridge in about 1854. Sucessive winters are now taking their toll and recent temporary protective works are being washed away. It awaits further funding.

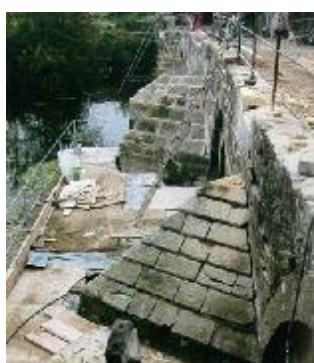
Work underway on the cutwaters during 2003

The bridge spans the river with four pointed arches. Three cutwaters were added to the upstream side in the 15th century and railings added in the 19th century.

By 2003 The bridge was getting rather tired and in need of some care & repair. The company which I run with my partner Andrew Sharland, Minerva Conservation, was awarded the contract for works, church repairs are our staple however we do enjoy the additional challenge of maintaining our conservative philosophy on structures as environmentally awkward as this. The structure was exclusively used by pedestrians so Wiltshire County Council were able to adopt a more hands off approach than it usually would toward bridges carrying vehicular traffic.

As is usual with projects of this nature previous inappropriate attempts at renovation had to be undone. Using an surprisingly stable pontoon system we Peeled back the layers one by one, removing areas badly damaged and jacked up by tree root growth, poor quality stonework & inappropriate modern materials previously fixed by contractors in the 1970s from a rubber dingy, (yes, its true ive seen the photos). We also removed the cracked Tarmac carriageway and dismantled the cutwaters, again to remove trees! Having previously worked extensively on the adjacent C18 Kennet & Avon Canal it was a surprise to see many similarities in construction, Why bother using lime mortars as a bedding & packing material when abundant locally sourced clay would suffice? It is waterproof, works well in compression, sets instantly is a good colour match and cheap.

Much original stonework survived in the arches as was evident by the adze marks left by the masons who had quarried the stone only a couple of hundred yards away. The fixing of the replacement stone in the barrel vaults could only commence once the resident Daubentons Bat (also known as water or fishing bats) maternity roost and their fledged young had been temporarily moved on to the surrounding poplar trees. Consecutive long evenings were spent on the pontoon with the local bat expert while he sealed roost holes & cracks (once the little critters had left to hunt for the night) this attracted the local drunks & constabulary in equal measure and ensured a regular food supply for the local invertebrates. Night was when the river really came alive, a primeval soup of midges that appeared at night lived just above the river & kept the large bat population well fed, by day squadrons of damselflies & dragonflies along with the odd kingfisher would alight on the pontoon. Roosts were recreated within the fabric of the arches and batboxes were created within large lumps of ashlar which have now been successfully colonised.

Temporary formwork in the barrel vaults supported stones adjacent to replacement elements. Limpley Stoke Ground limestone was found to be a ideal match & was cut, dressed & fixed by colleagues with whom we had worked at our time at Salisbury Cathedral. The bridge was repointed & grouted using a naturally hydraulic lime mortar (NHL5), a Cotswold limestone Thames aggregate from Moreton Cullimore created a satisfying and texturally pleasing mortar, it was vital that we used a heavy duty mortar which could be guaranteed to have achieved a set properly before the winter with its frost & floodwaters which regularly rise above the bridge handrails.

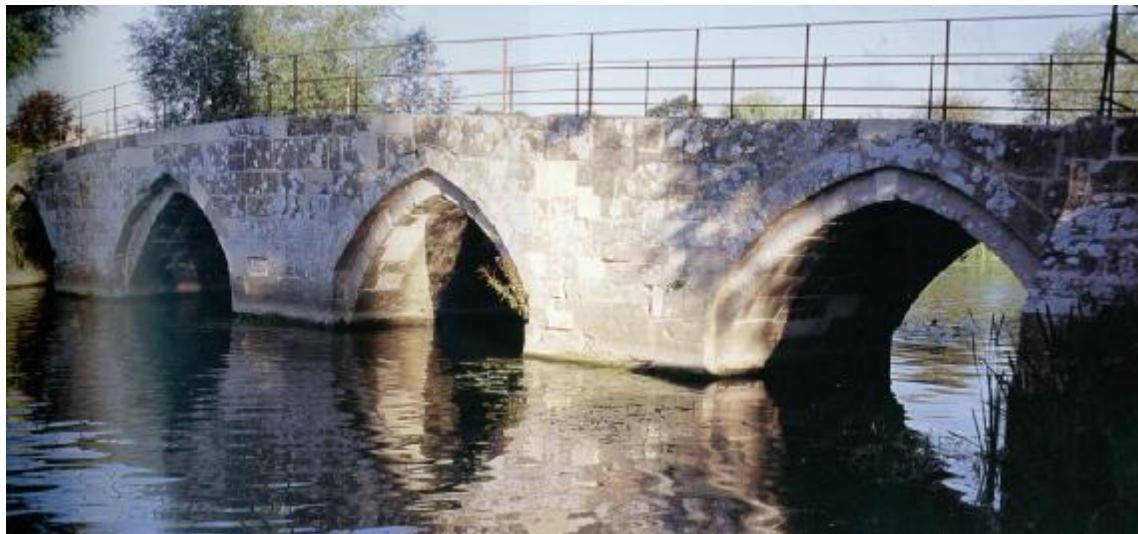
Barton Farm Bridge as it is today.

Research into past surface materials of the carriageway suggested that it was originally paved with crushed limestone which was replaced with stone setts in the 19th century. The tarmacadam surface which was put on in the 1940's was replaced with hydraulic lime concrete. This has created a hard, durable surface which nevertheless allows evaporation of trapped water in the bridge after it becomes saturated. The new carriageway is also cambered to allow rainwater to run off via new Forest Marble cobbled gullies. The railings are recognised as a good example of 19th century rural craftsmanship and are in harmony with the original stonework. A new wrought iron handrail was made and fitted on the upstream side, the railings were left unpainted to allow the natural patina of the wrought iron to develop.
