## Gls, God and the Great Western

Dating from the 1200s, tiny St Mary's Church at Old Dilton, Wiltshire, has recently been a place of work for conservation mason Andrew Ziminksi. He reflects on the personal histories accumulated in a building repaired by the SPAB and now in the care of the Churches Conservation Trust. Photographs John Lawrence

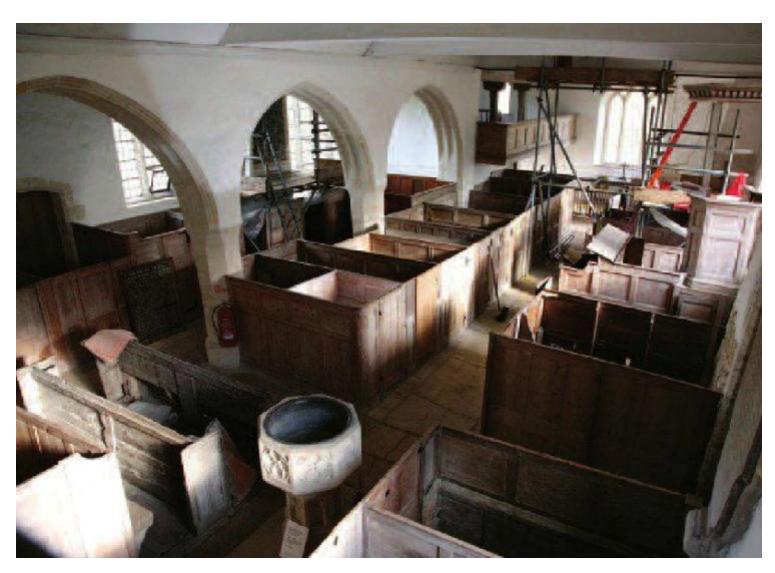
The gallery north of the chancel was once used as a schoolroom and contains a fireplace, which is the only nod to modernity of comfort; even now the church is powerless.

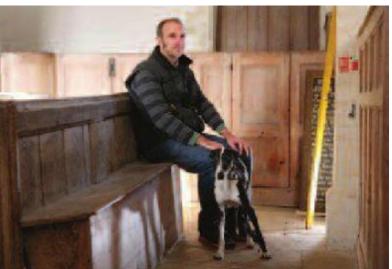
Above (from left)
Georgian box pews at
St Mary's; guttering
came late to the
church, and damp
had been a familiar
problem; Andrew
Ziminski contemplates
another day's work at
St Mary's, encouraged
by his hound

tackling the effects of damp and ongoing rot to the bases of the box pews. The big problem is water ingress, as a photo of 1905 testifies. St Mary's has never had any gutters nor, more importantly, an adequate stone slated barn-type eaves detail to throw water clear of the building. Consequently, timber pew bases against wall areas were damp and decayed by brown rot and probably cellar rot (Coniophora puteana). Weevils feed on this early stage mulch and thus compound the decay. Underneath the pulpit there was a large body of decaying timbers of different ages, suggesting a long history of problems. Application of chemicals to kill the fungus would not destroy mycelium (the "roots" of the fungus that absorb nutrients) as they are within the rubble walls and could be seen behind the more modern plaster when it

John Wilson (our archaeological carpenter) and I have taken large areas of the internal floor apart, reduced earth levels and removed fungal fruiting bodies. With the new drains and guttering we hope to have reduced moisture levels enough to deny the rot its food source without the use of chemical treatments.
