<u>Health and Safety file. Roman Baths Development</u> <u>Project</u>

Observations and catalogue relating to Conservation work undertaken, fixings used, information for future residual risks and safe systems of work for future moves.

MINERVA STONE CONSERVATION

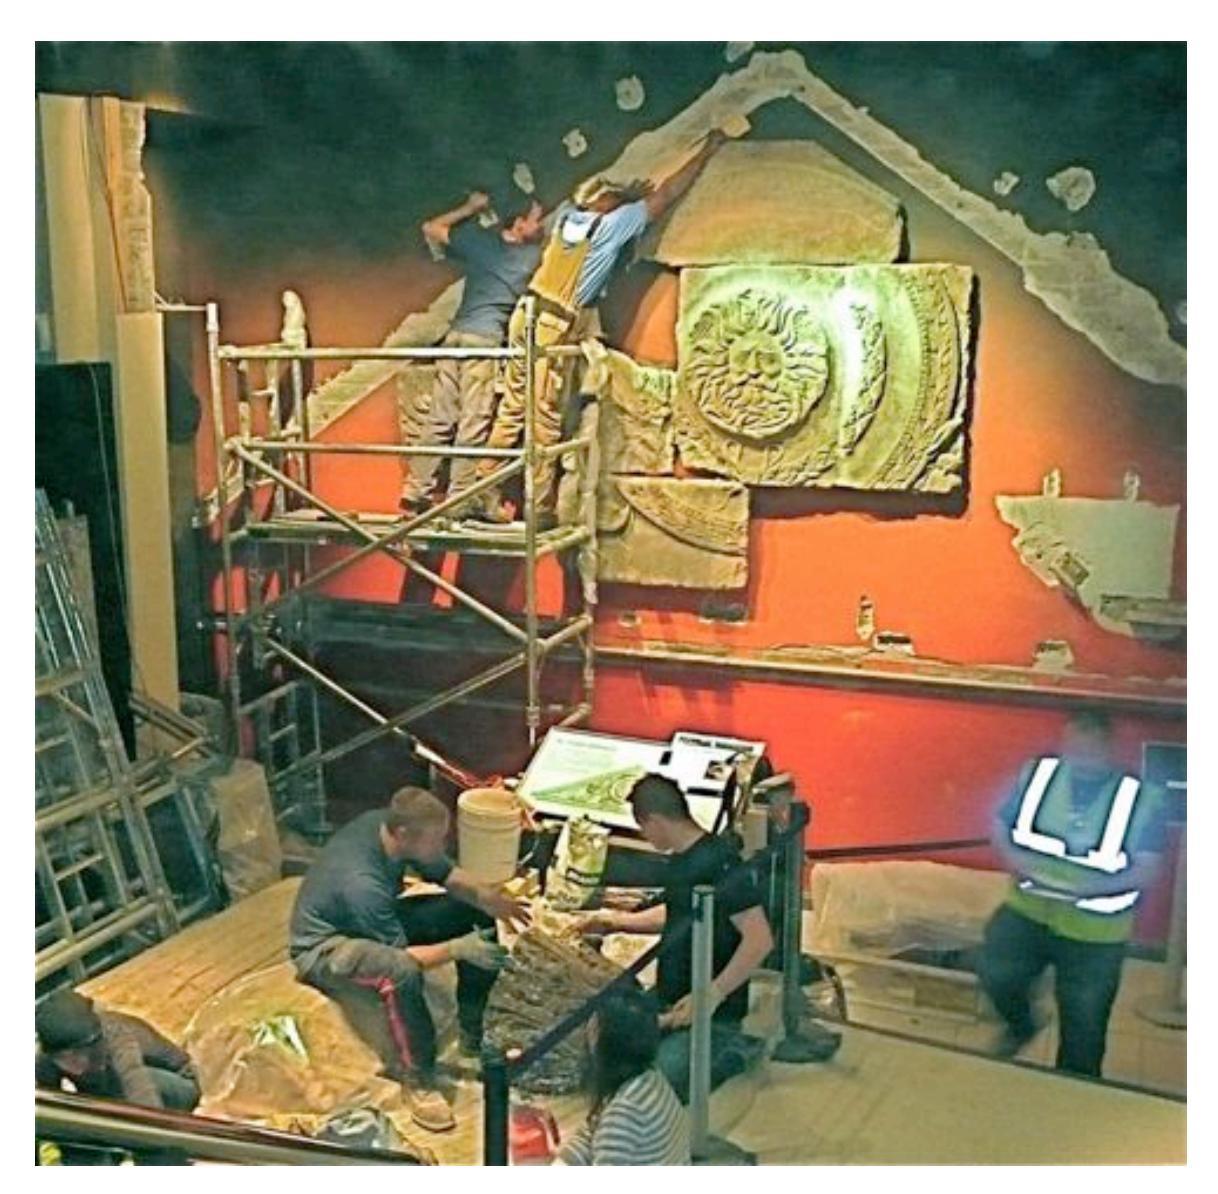
Re-arrangement of Temple Pediment.

Elements of the "Gorgon Pediment" were adjusted and moved, the angle of the cornice was adjusted. The adjacent Column and Capital was moved and fixed into new wall positions.

Stainless steel flat bar, felt cushion (fixed around the body of the stone) seated on equal angle- iron bracket.

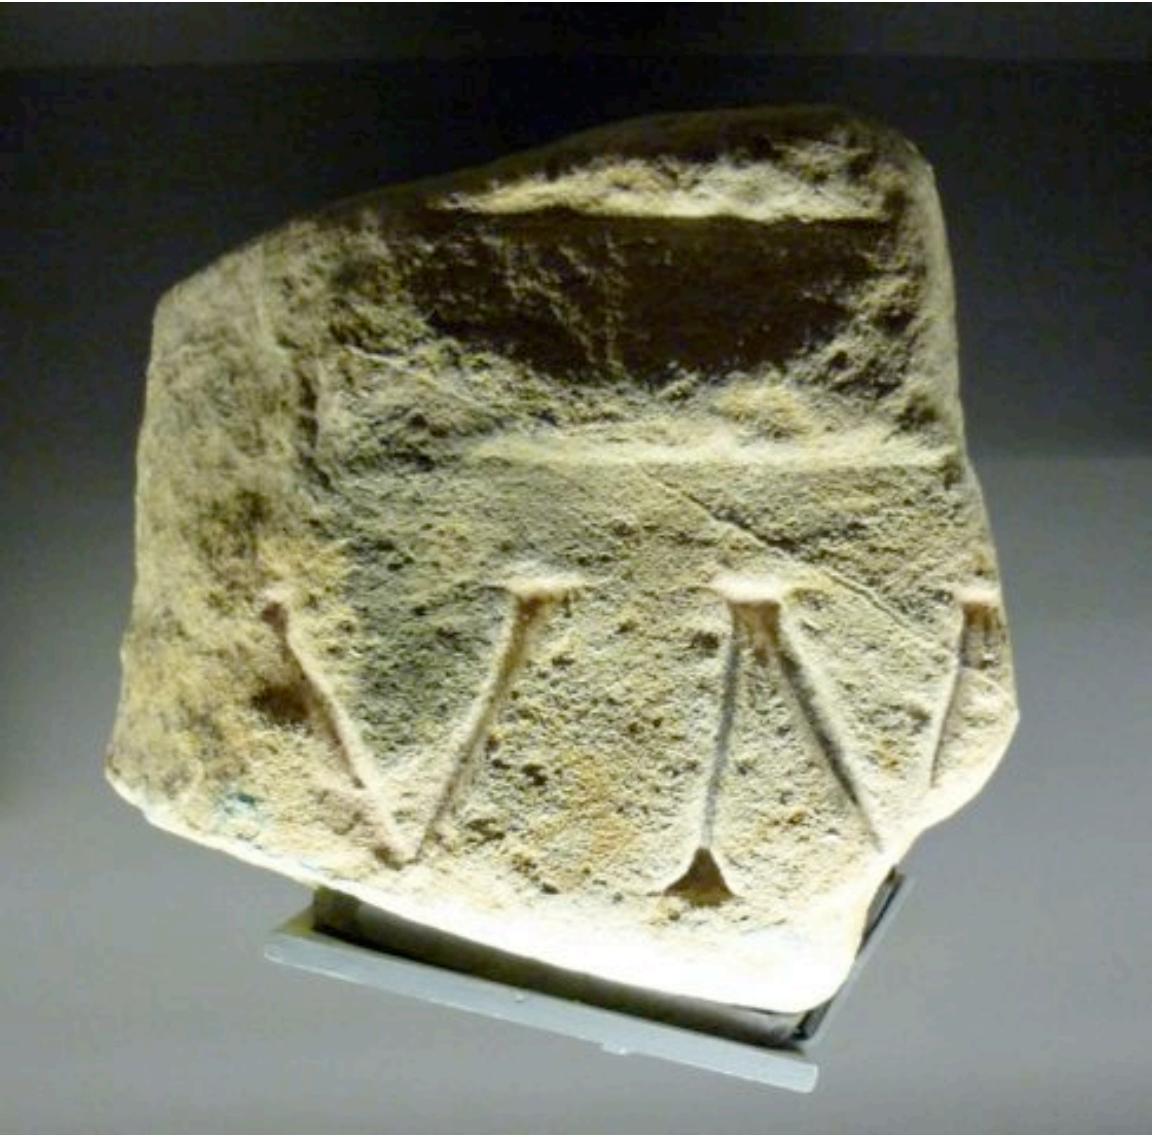
VM Stone

1. Description of work undertaken to 3 Pediment fragments. Fragments moved from storage and sat on into new position on new brackets and Vacuum cleaned.

The objects sits on a 10mm unequal angle plate bolted to the wall and restrained (using existing fixing points/holes) with Stainless flat bar.
